Acid Sulphate Soil Investigation of Southern Yellagonga Regional Park Report: Stage 2

Prepared for,
Cities of Joondalup and Wanneroo

Centre for Ecosystem Management
Report No. 2013-9

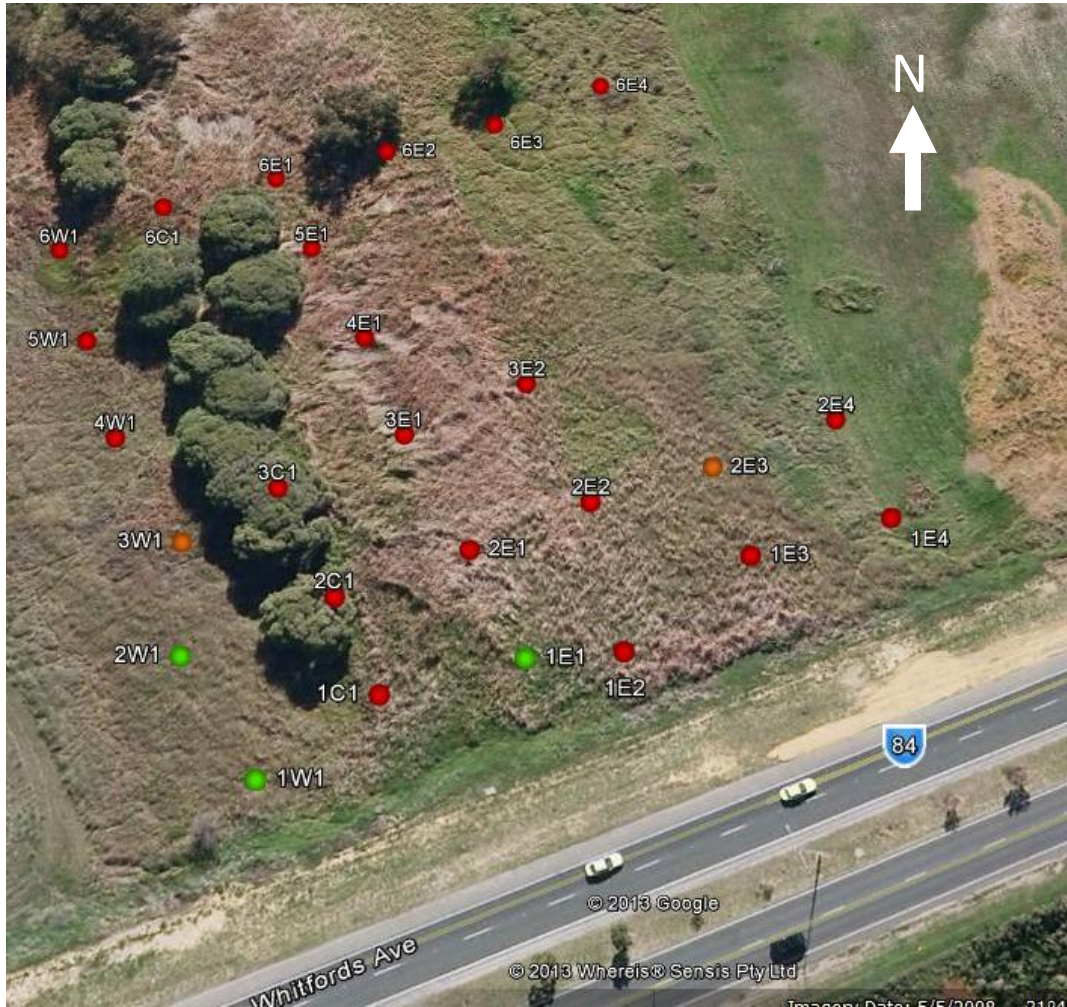
A 10000 m² area was sampled overlaying the previous sampling sites (Newport *et al.*, 2011b) and extending westwards, eastwards and northwards, running parallel to Whitfords Avenue (Figure 2). A grid spaced at 20 m intervals was used to determine the location of sample sites. At each site, soil samples were collected to a depth of 1.5 m.

Figure 2. Illustration of the sites where sediment samples were collected to a depth of 1.5 m. Green indicates sites where soil types throughout the profile did not exceed the action criteria, amber indicates sites where soil types throughout the profile were equal to the action criteria and red indicates sites where soil types throughout the profile exceeded the action criteria. The action criteria were based on SPOCAS and SCR results.

Table 2 illustrates detailed individual soil profiles and depth to groundwater of all sites sampled. When used in conjunction with Figure 2 it can be seen that the distribution of positive ASS soil classifications covered all but the south-west corner of the study site.
