## Point Fraser Monitoring and Evaluation Program

2011 Report

Report No. 2012-2

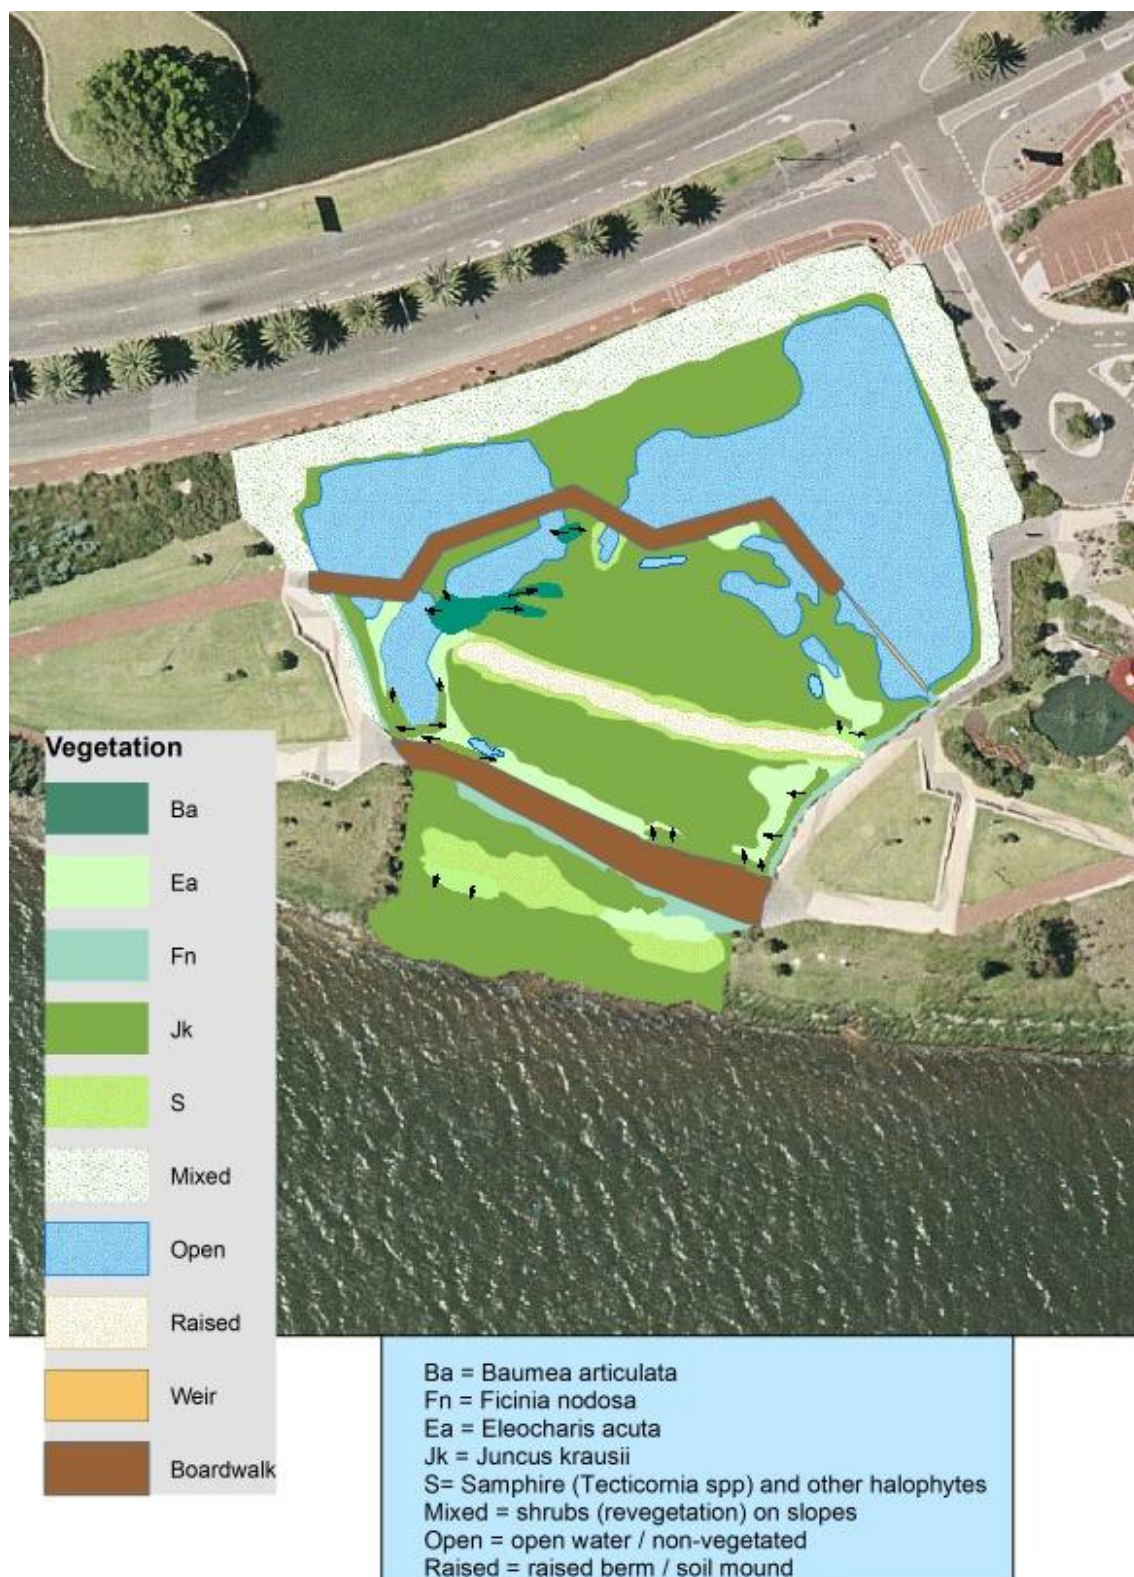
- Mixed shrubs on embankments – this community consists of a range of shrub species with medium to high cover. Dominant species include *Scaevola crassifolia*, *Kunzea ericifolia*, *Myoporum caprarioides*, *Ficinia nodosa* and *Atriplex cinerea*. Most of these species were planted around the edge of the wetland.
- Open Water – no plant species were found in these areas (although filamentous algae was common). Three new areas of open water have developed in Zone 2 over the last year (albeit small in size; Figure 15).

**Figure 15.** Map of vegetation types and other cover as of October 2011. Changes from 2010 and general direction of expanding vegetation types are indicated by arrows.

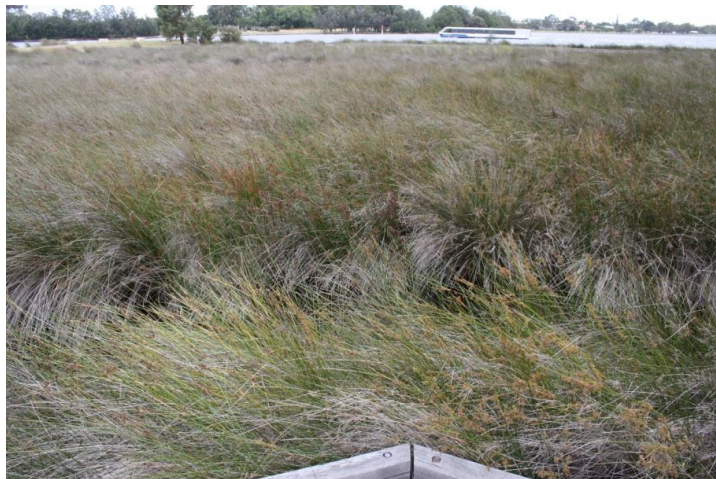
**Figure 17.** Photograph taken at photopoint WV2 looking south. Vegetation here is dense *Juncus kraussii* and its extent and condition is generally stable

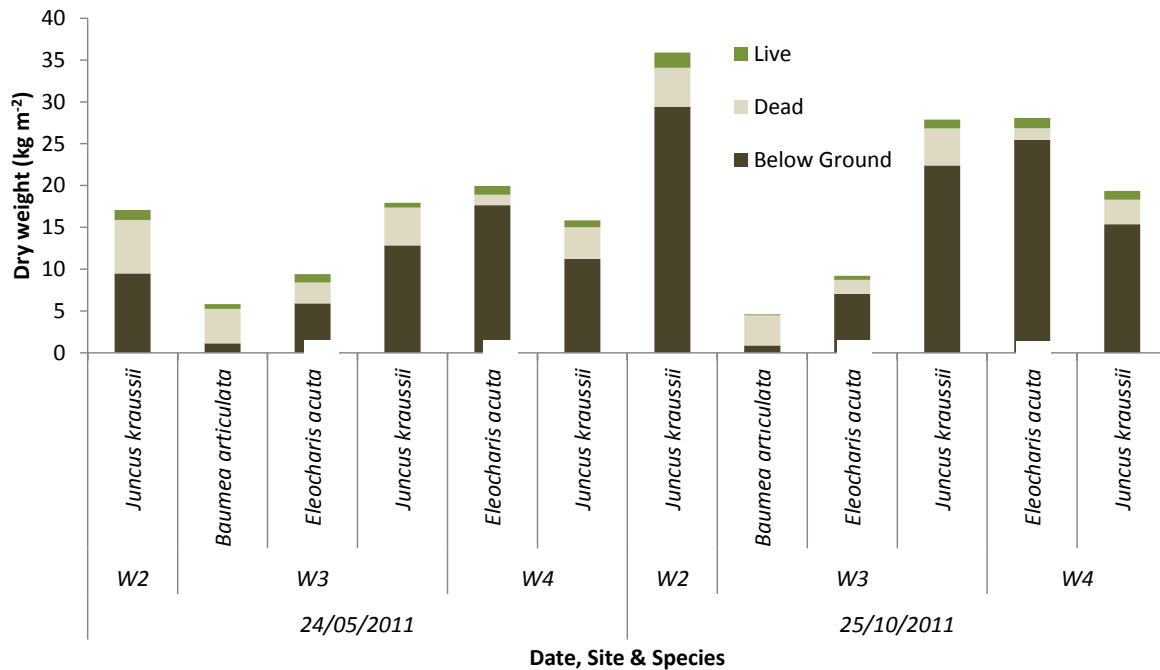
*Baumea articulata* had low below ground biomass, virtually no live material above ground and a high proportion of dead material in both May and October (Figure 24). At the end of 2010 this stand was growing and expanding, however despite the higher rainfall in 2011, the stand appears to be dying. This may be due to high salinities or unfavourable water depths. It is uncertain whether the stand will recover. Below ground biomass in other species increased between May and October although there was little difference in live or dead above ground material. The biomass of the plants varies between species and ponds.

**Figure 24** Mean dry weight (g) of live, dead and below material from collected species, from sites on two occasions.

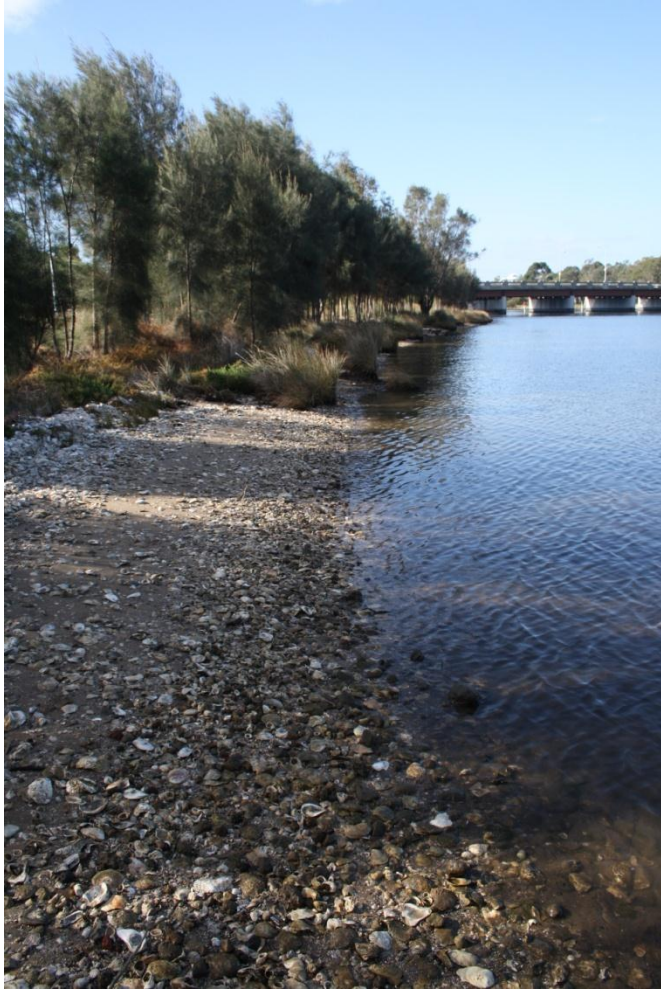
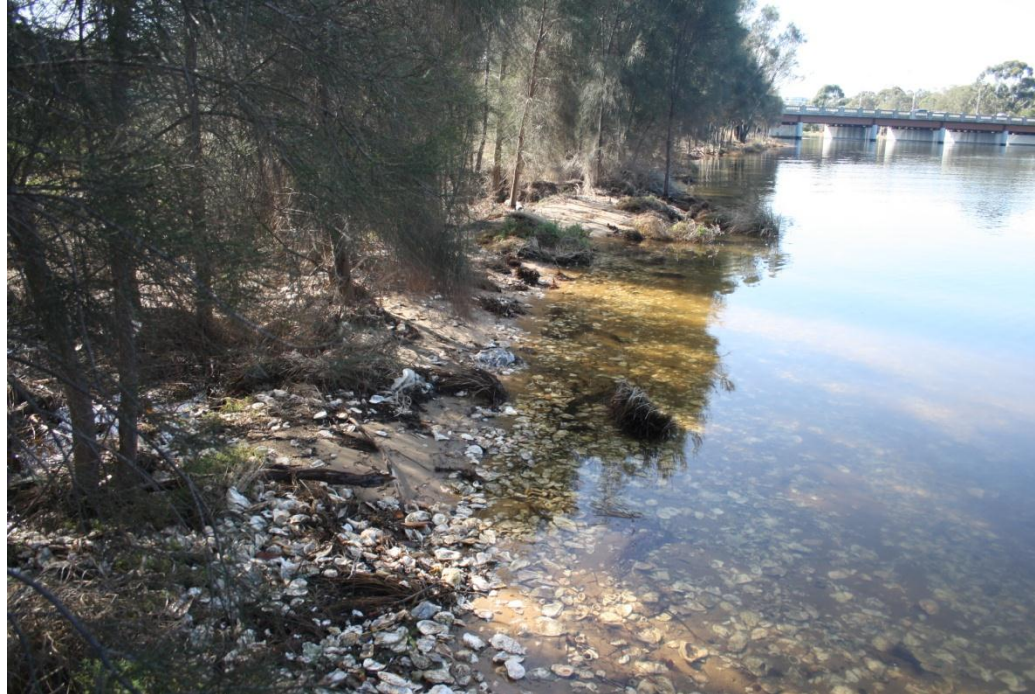
Photographs taken at Foreshore Monitoring Site 1B in an Easterly direction  
May 2010

Monitoring Area 1 has experienced a clear deterioration in foreshore condition during 2011 with greater proportion of foreshore being classified as having significant to severe erosion (Table 14). Planted and naturally colonised areas of *Juncus* and other fringing wetland plants have dramatically declined along this section of foreshore and this appears to have made the sediment in this area more prone to erosion by wind- and boat-driven waves (see Section 7.6). Subsequently sediment has been lost around the *Casuarina* grove up slope, exposing root systems and jeopardising the health of this previously healthy stand of trees (see photos at Appendix 1).

It is recommended that Area 1 (including the headland between Areas 1 & 2) receive immediate remedial treatment in the form of sandbagging and planting of fringing sedges/rushes to reduce erosion and help prevent further loss of trees.
