Point Fraser Monitoring and Evaluation Program

2014 Report and 5 Year Report

Prepared for,
City of Perth

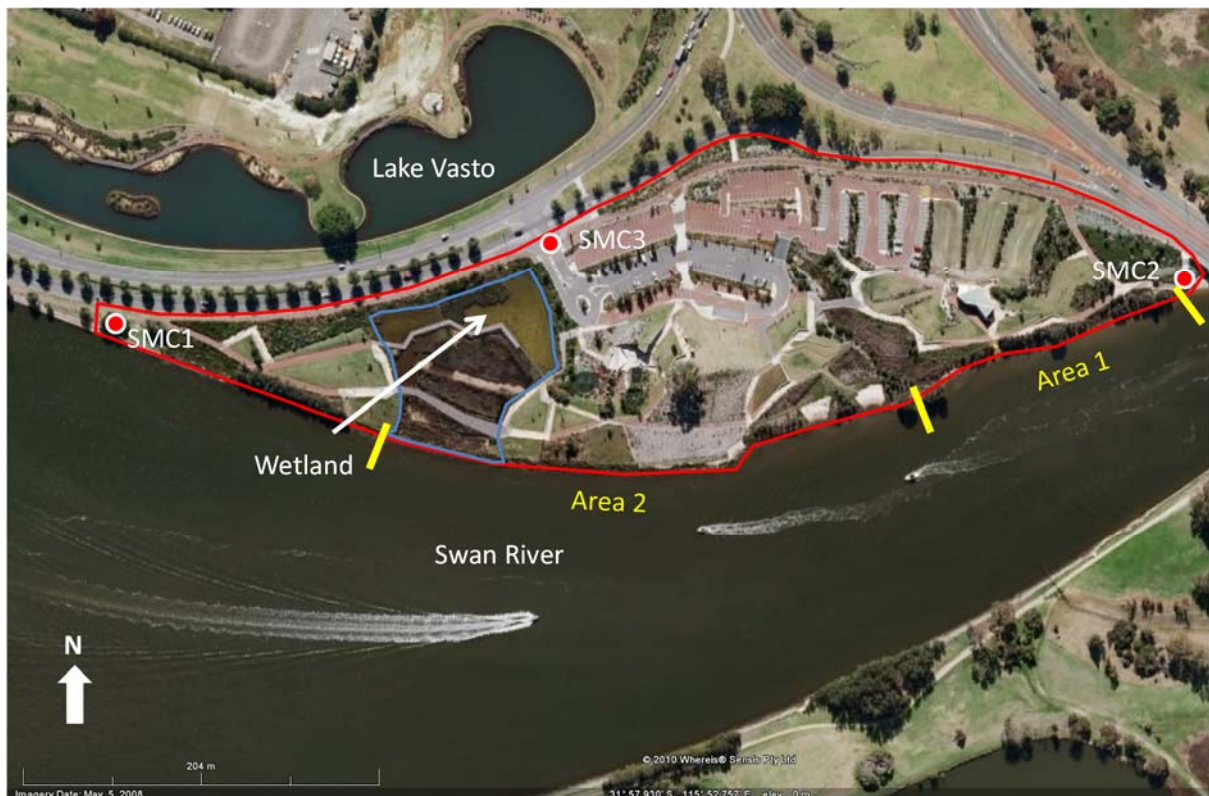
Figure 3. Aerial photograph of Point Fraser (bounded by the red line), showing the constructed wetland (bounded by the blue line), Lake Vasto, the social monitoring sites (red and white circles, SMC1-3) and the foreshore monitoring areas (yellow). Photograph adapted from Google Earth, 2010.

The majority of the study was conducted in the constructed wetland in the Point Fraser reserve, however foreshore monitoring occurred in two areas (1 & 2) while avifauna and social monitoring were conducted across the entire reserve (Figure 3).

In May and October visitor counts and visitor observations was undertaken. Social monitoring for each round was carried out between 7 am and 6:30 pm on a weekday and weekend day. Surveyors were based at each end of Point Fraser (see Figure 3) capturing walkers and cyclists moving through the park, a third person was based near the road entrance to capture people using the Point Fraser car-park for visiting the city. On the hour, for the first 15 minutes, the numbers of people and vehicles entering or leaving the park were recorded at the three sites on Observation Count data sheets. Between the hourly visitor counts, a surveyor walked from the east to west entrance ensuring all areas of the reserve were covered and recorded the behaviour of park users using the Observation Behaviour datasheet. An aerial photograph was used to mark the location of stationary park users. Copies of the datasheets are appended.

In May, the foreshore of Point Fraser was monitored at 3 sites in each of the two areas shown in Figure 3. Photographs were taken at each site and condition assessed. The locations of the foreshore monitoring sites are shown in Figure 7.

Visitor Observation Counts recorded the number of people undertaking a particular activity (limited to walking or cycling) by a staff member located at three sites, SMC1, SMC2 and SMC3 (Figure 3) across Point Fraser.

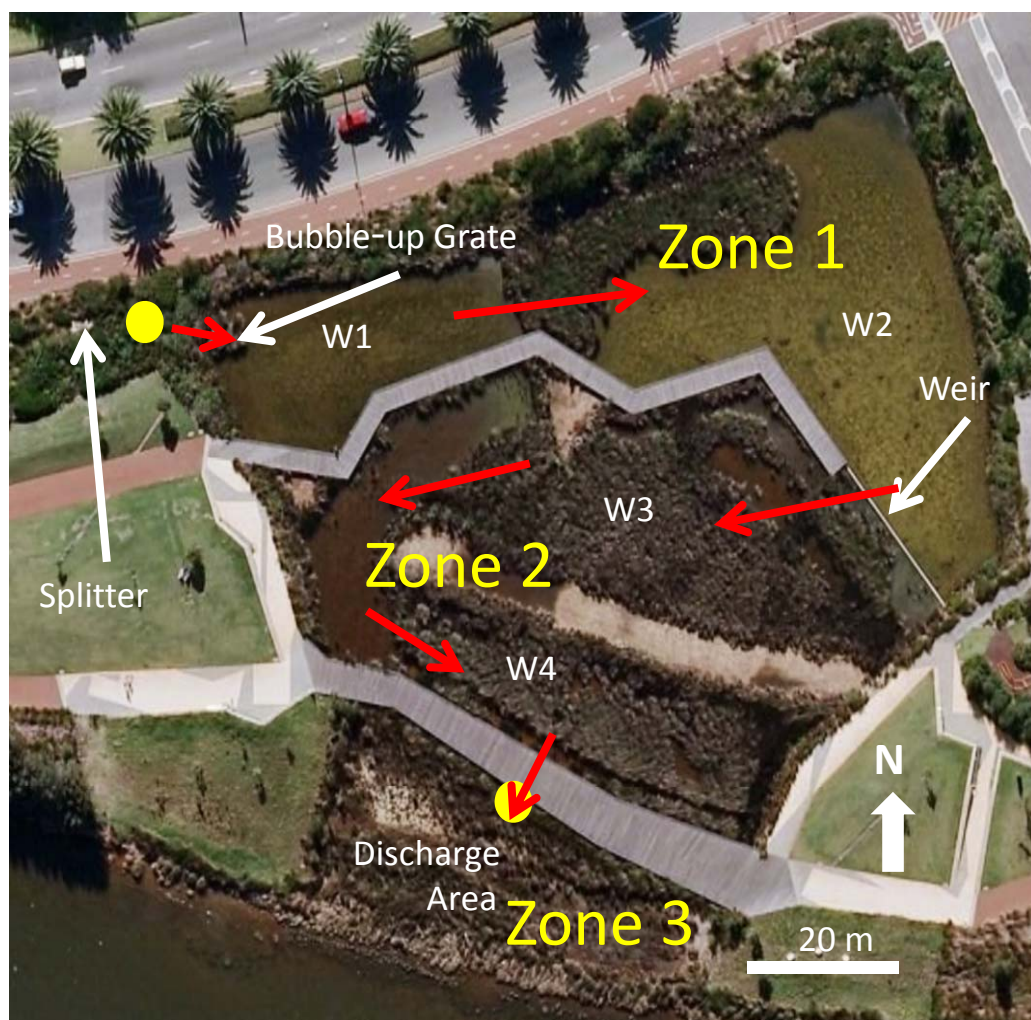
Figure 4. Aerial photograph showing the movement of water (red arrows) through the Point Fraser constructed wetland. Yellow circles mark the fixed inlet and outlet monitoring structures. Sampling sites are indicated as W1 to W4. Imagery adapted from Google Earth, 2010.

exceptionally high flow conditions. A similar weir lies under the boardwalk separating the discharge area from W4. This contains a valve to prevent ingress of water from the Swan River at times of exceptionally high tides, while also permitting exceptional high water levels in W4 to discharge. W1 to W4 are lined to prevent interaction with underlying acid sulphate soils (Syrinx Environmental PI, 2009). W1 and W2 are covered with a thin layer (approx. 20 mm) of Supersorb activated zeolite clay, while W3 and W4 have layer of soil (100-200 mm deep) to grow plants in. The cleared strip between W3 and W4 is actually a small mound that effectively prevents water moving directly from the weir to the discharge point. Excessive build-up of salt in the mound, resulted in removal of the surface layer (Syrinx Environmental PI, 2008), which is why it is currently devoid of plants. As stormwater flows infrequently into the wetland, the ponds W1 and W2 (which must remain under 250-300 mm of water and W3 and W4 which must be under 50-100 mm of water must be topped up with water taken from Lake Vasto (Syrinx Environmental PI, 2009).

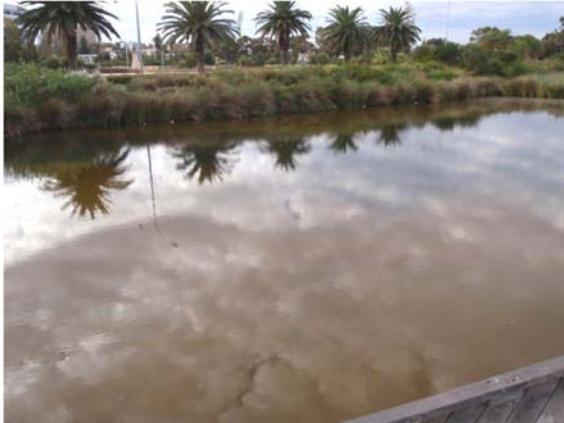
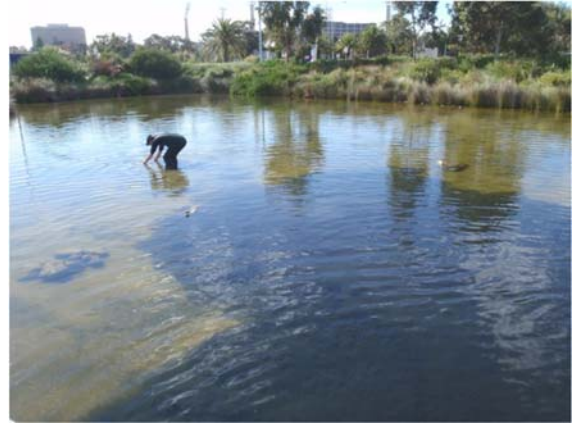
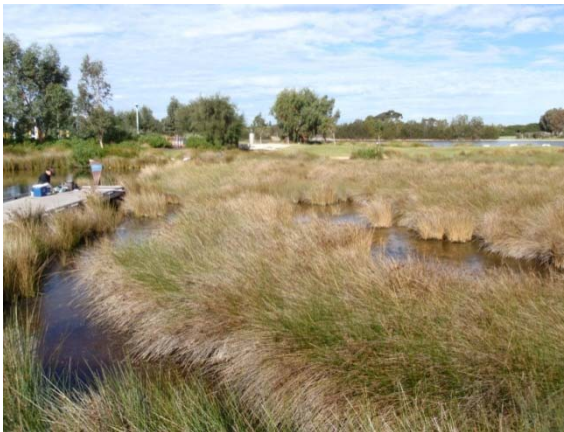
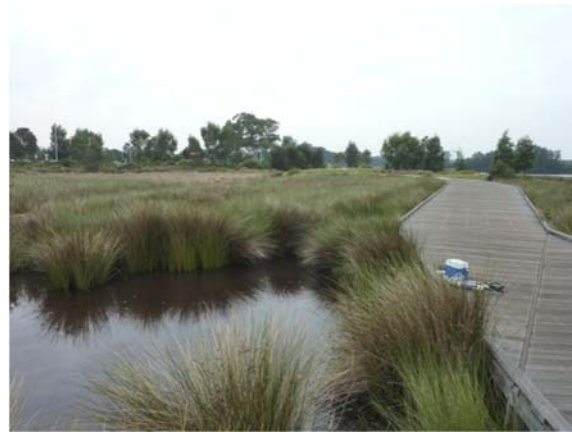
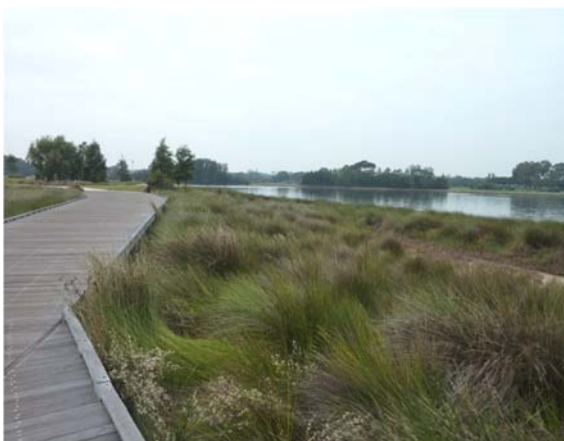
a) W1

b) W2

c) W3

d) W4

e) Discharge area (Zone 3)

Figure 5. Photographs of the sampling sites in Point Fraser constructed wetland

Photographs of all the sampling sites are shown in Figure 5.

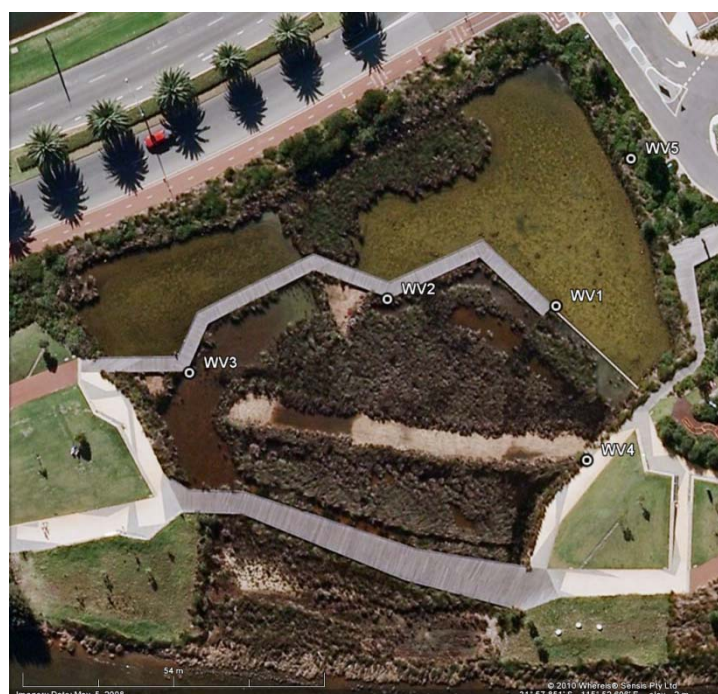
Figure 6. Location of vegetation monitoring photopoints (WV1-WV5)

In October and May, the wetland vegetation was mapped. Photographs are taken at fixed points (Table 1; Figure 6) to record vegetation health.

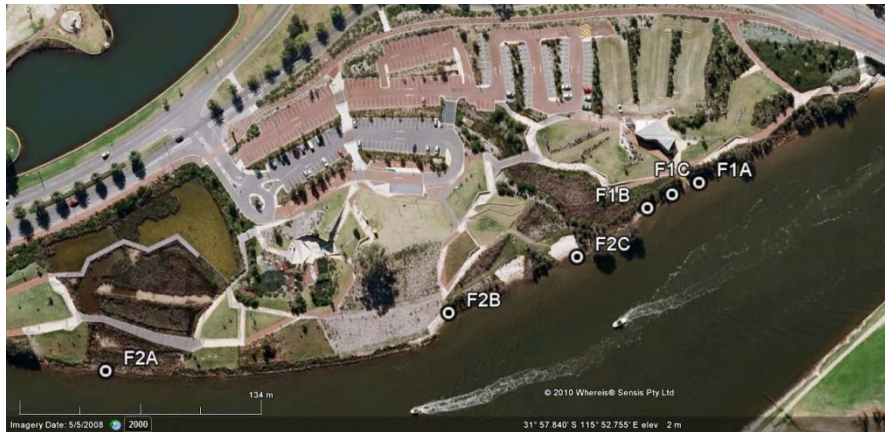
Figure 7. Locations of the foreshore monitoring sites (F1A-C and F2A-C) (taken from Google Earth 2010)

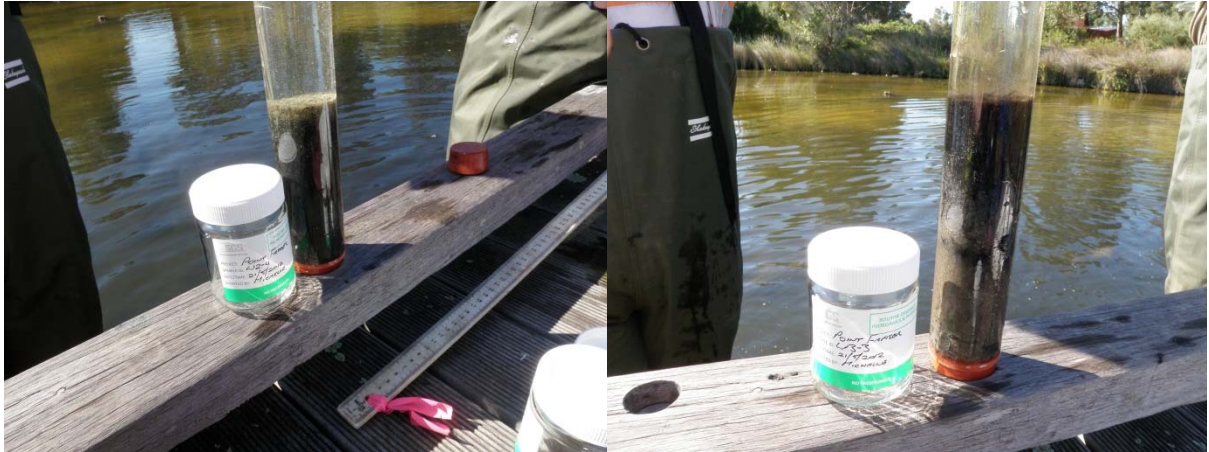
W2 is designed to aid settling of particulates and with the addition of zeolite to bind cations (positively charged ions) such as metals and ammonium. Comparing metal and nutrient concentrations from 2010 to 2014, Only TOC and Total P increased in concentration up to double for TOC. All other metals and nutrients declined in concentration. A possible explanation is that accumulation of particulates has buried the zeolite and the deposited particulates are less effective at retaining nutrients and metals. In contrast, W3 was designed for plant removal of nutrients and metals, however the sediment has proved very effective at removing nutrients with TOC, Total P and TKN all increasing in concentration at least two fold over the time period, additionally Mn and Cr have also increased. All other metals have remained largely unchanged or possibly have declined. The area of W3 sampled is just after the weir where there have been no plants. The results suggest that the sediment used in W3 is superior for nutrient removal than the zeolite enhanced sediment, especially if the zeolite is continually being buried by particulates.

Figure 18. Photograph of a sediment cores taken at W2 (left) and W3 (right).

7. It is not recommended to add more or replace the Supersorb clay in W1 and W2 as it appears to make little contribution to nutrient uptake within the wetland.
8. Ongoing annual sediment monitoring for metals and nutrients is not recommended. It is recommended that sediment monitoring every 2-3 years would be useful.
9. It is recommended that the sediment in W2 not be allowed to accumulate to be above the base of the weir between the two zones. The rate of accumulation of sediment is relatively low at present but may increase with larger inflows.

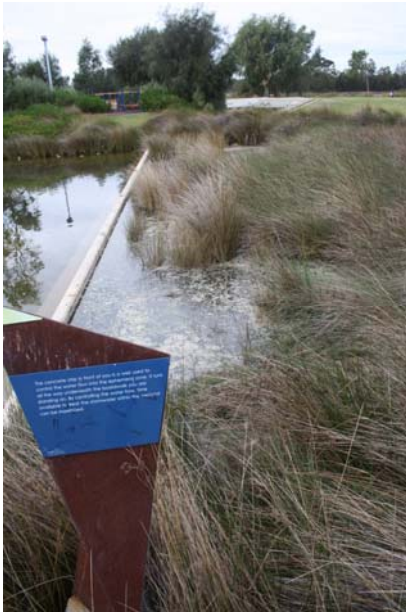
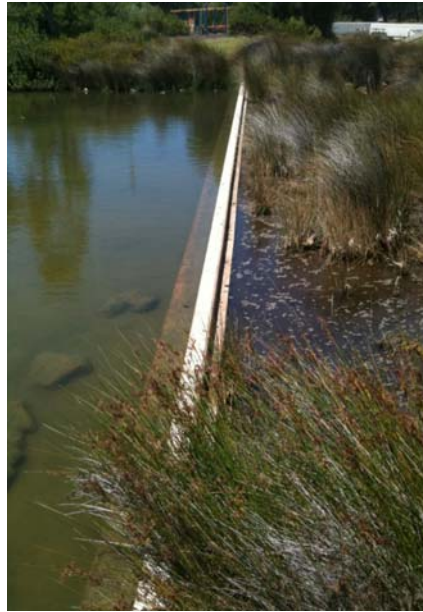
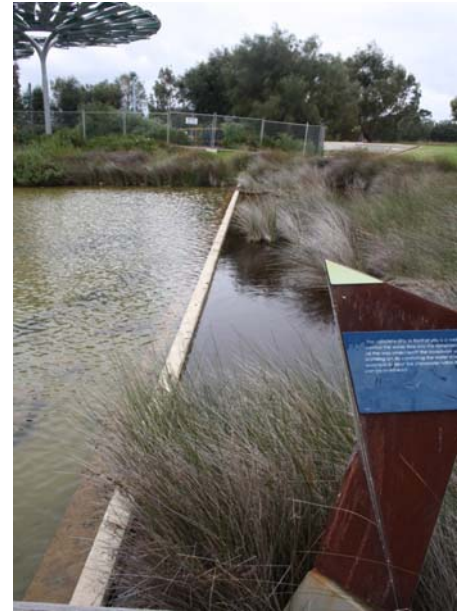
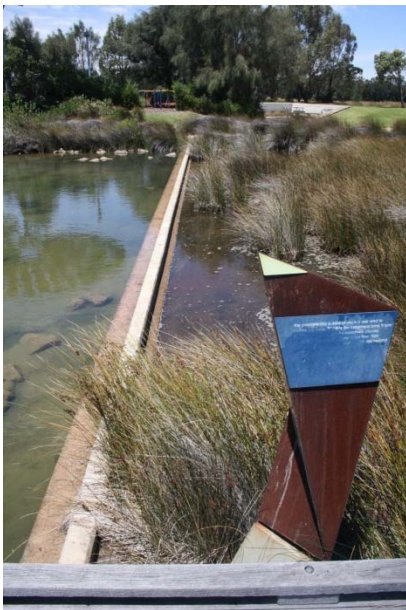
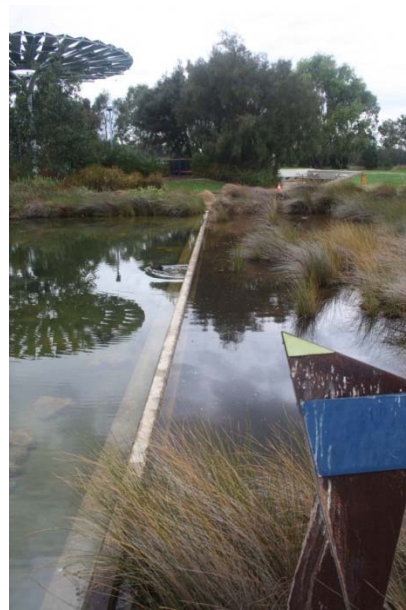
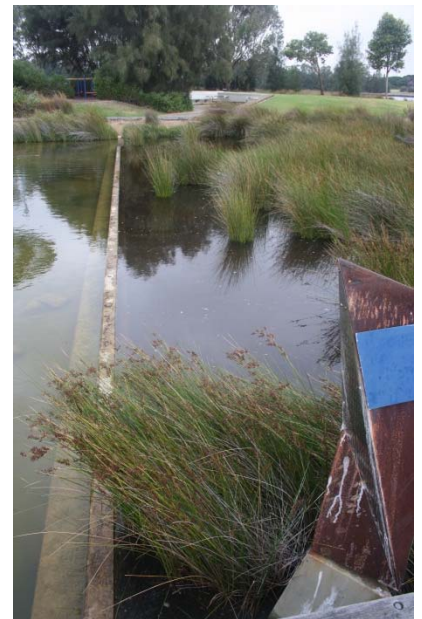
Figure 22. Photographs taken at photopoint WV1 looking south-east. Note the increase in open water areas on right hand side of weir.

A photographic record of each vegetation community was taken at fixed locations (Figure 22 to Figure 28).

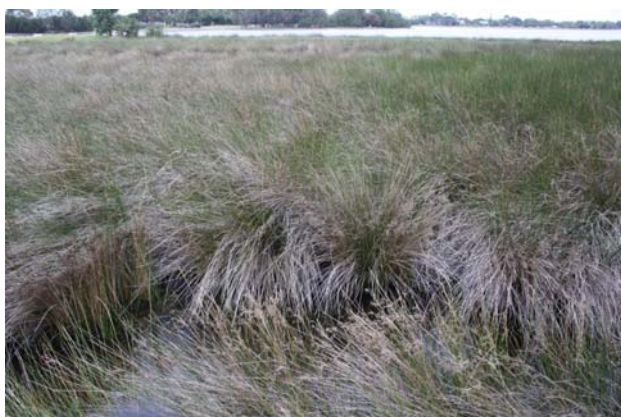
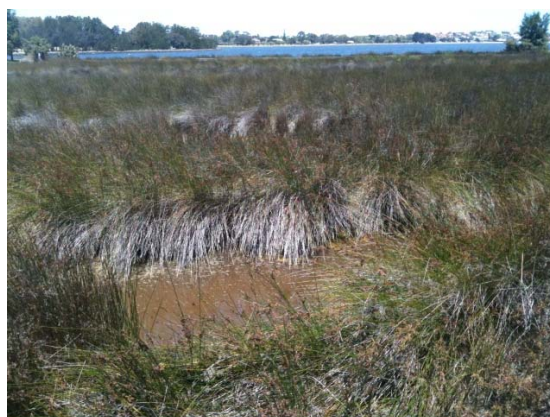
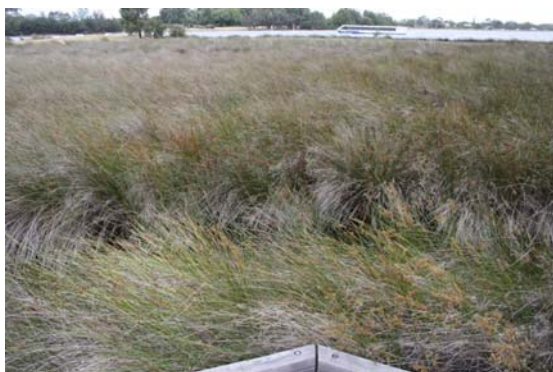
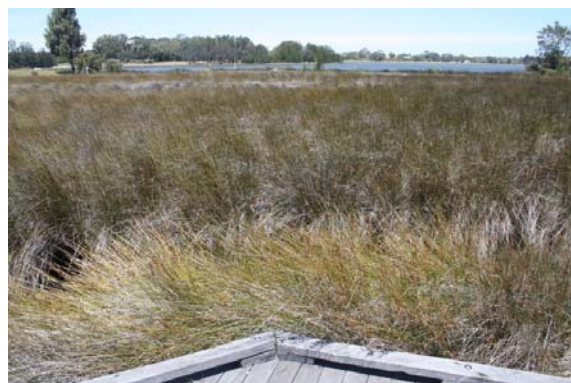
Figure 23. Photograph taken at photopoint WV2 looking south. Vegetation here is dense *Juncus kraussii* and its extent and condition is generally stable, although open water is expanding in the foreground

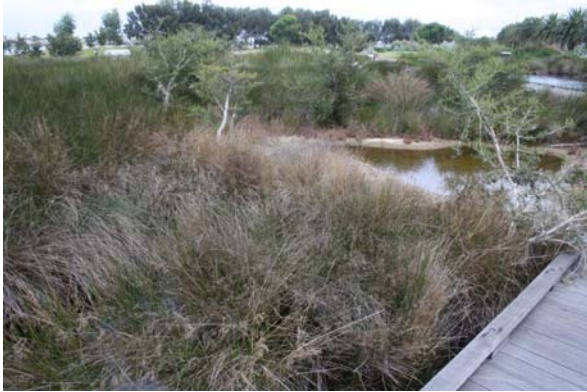
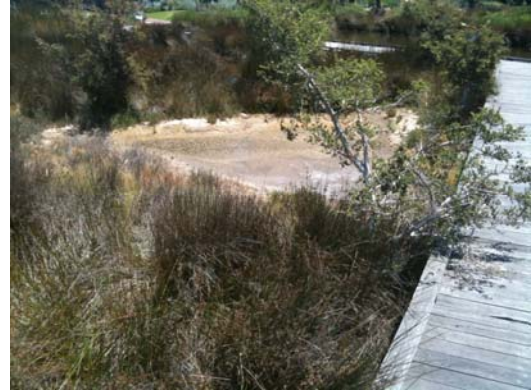
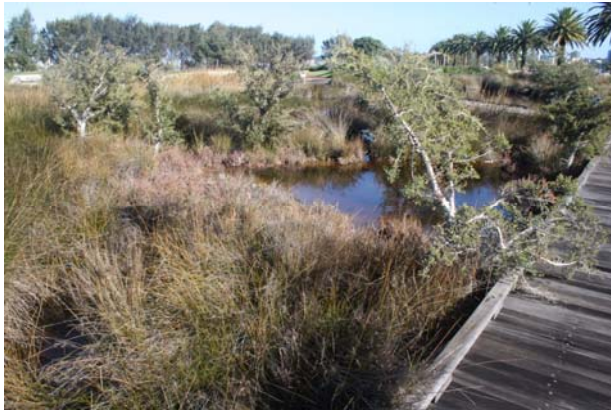
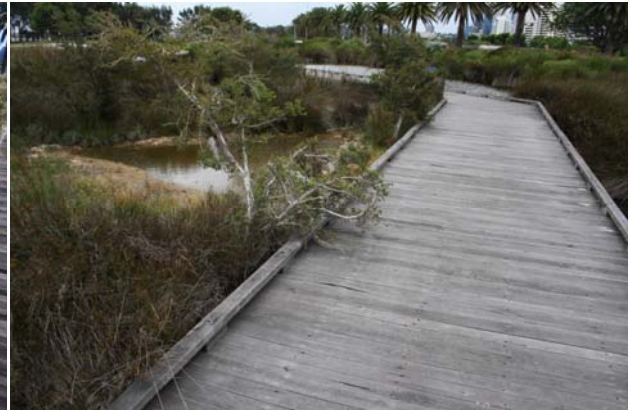
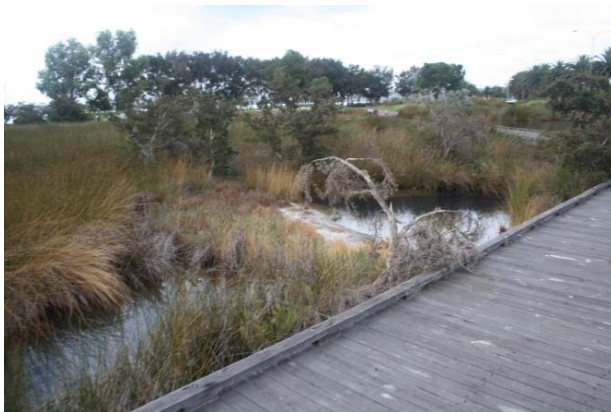
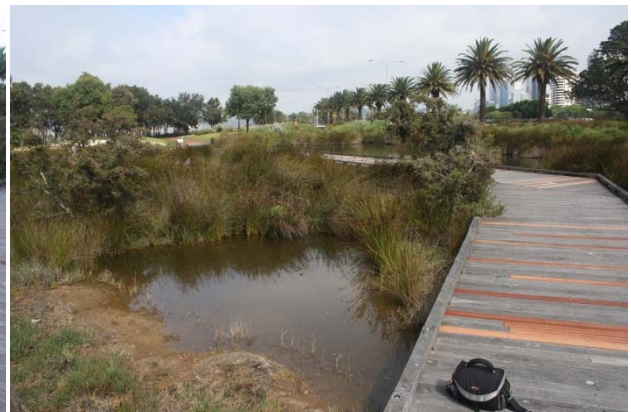
Figure 24. Photographs taken at photopoint WV2 looking west towards patch of *Melaleuca* trees. One tree has died (close to boardwalk), whereas the other appear to be healthy but growing only slowly.

Melaleuca cuticularis – two patches of young trees were observed on slightly raised mounds, both within Zone 2. These are most likely plants surviving from original planting in 2004. The trees are mostly found on the margin of *Juncus* community where it abuts samphire/halophyte community. One mound had 6 trees in 2010; one of these died during 2013. One tree was unhealthy in 2013 but appears to have recovered in 2014, suggesting that these trees are generally healthy (Figure 24). The other mound had 10 trees in 2010, and all these appear to be healthy in 2014 and are now approximately 2-2.5 m tall.

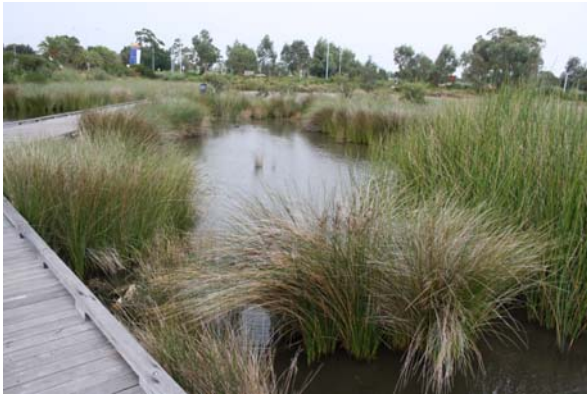
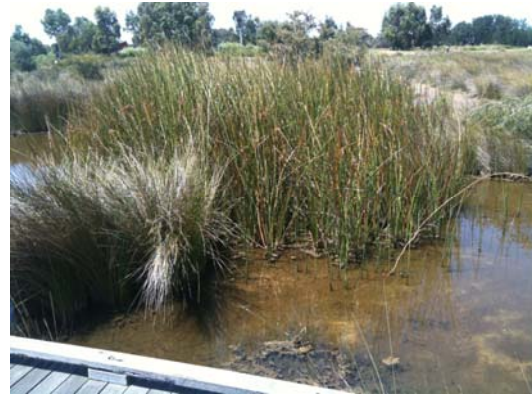
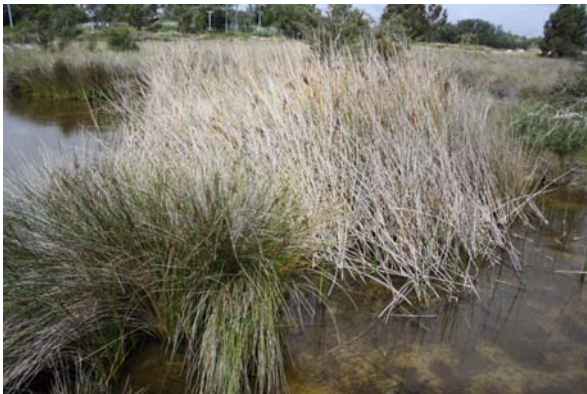
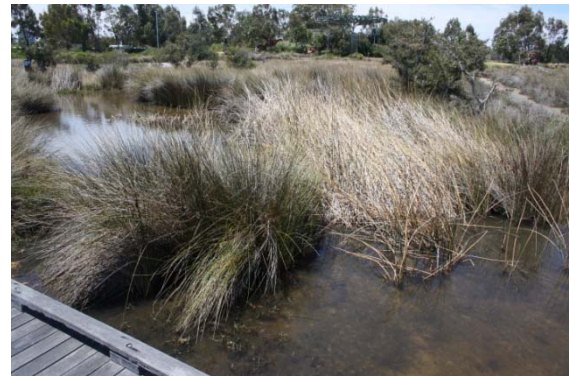
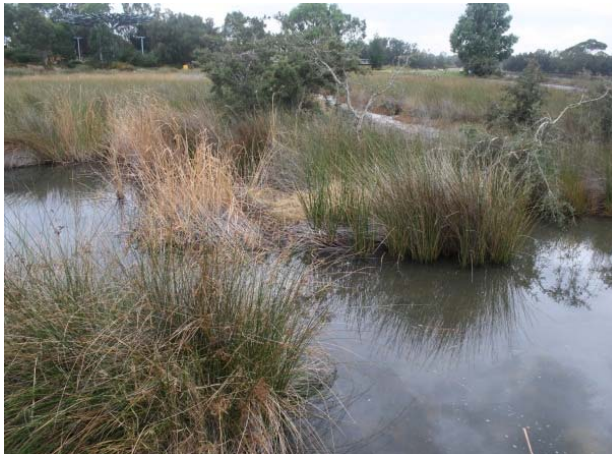
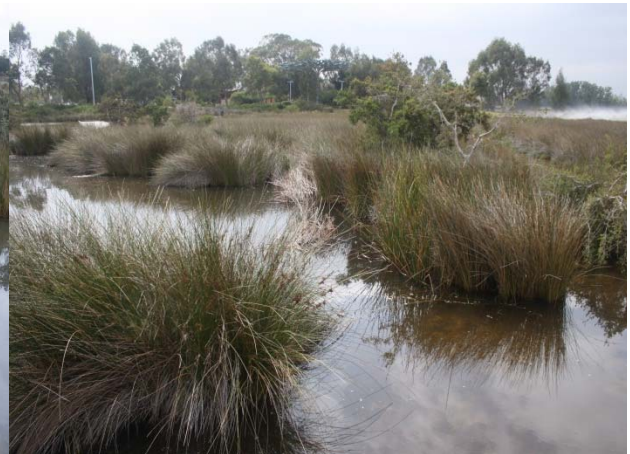
Figure 25. Photograph taken at photopoint WV3 looking east (note expansion and subsequent death of *Baumea articulata* over the years). Photos have been taken in slightly different directions (top is due east, whilst others are ESE to focus more on the declining *Baumea*).

The decline of some other plant communities was much smaller in terms of absolute area but, as they were generally restricted in distribution, was generally much greater in terms of proportional change (Table 7 & Table 8; Figure 21). In particular, the *Baumea articulata* community declined by only 16 m² in period 2010-2014 but this reduction was 95% of its original distribution. This community would be expected to disappear in the near future. The decline in *Ficinia nodosa* community has been modest (only ~15 m²). This community mainly occurs on higher ground around the edge of the wetland so is less likely to be affected by changes in water levels and quantity.

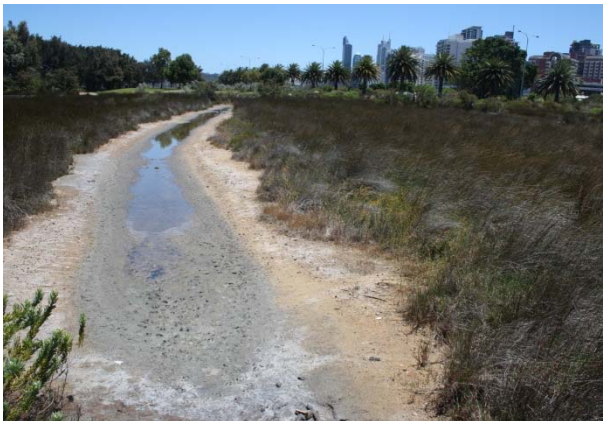
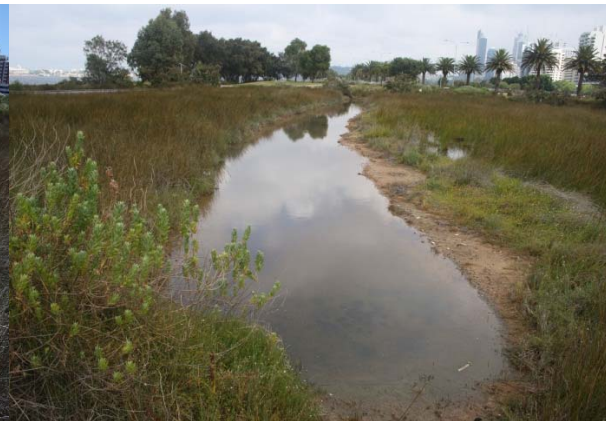
Figure 26. Photographs taken at photopoint WV4 looking west along drainage culvert. Note samphires and other halophytes on the banks of the culvert, and increase levels of surface salt. October 2014 appear wetter than previous years.

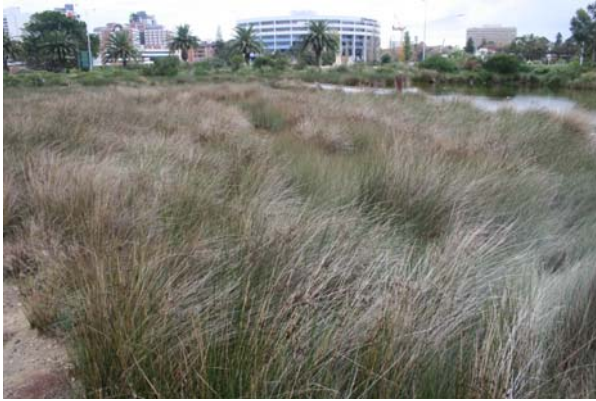
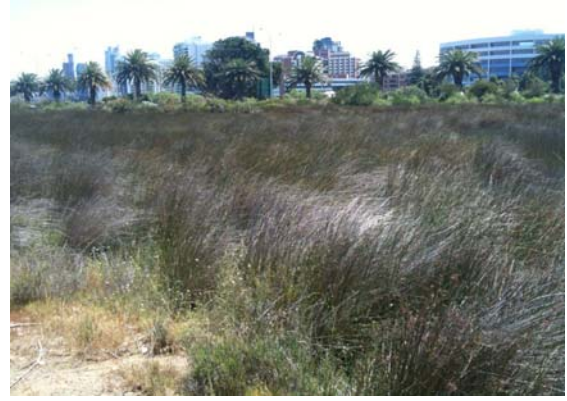
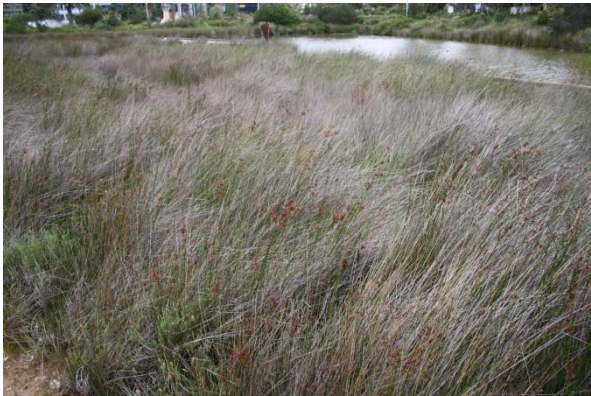
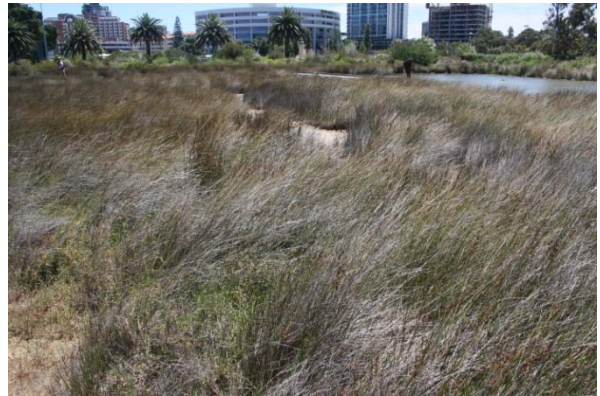
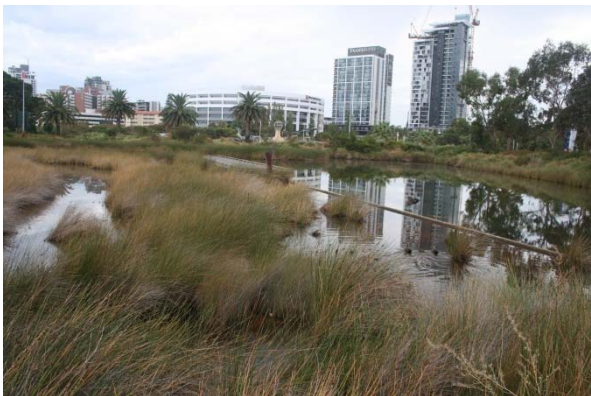
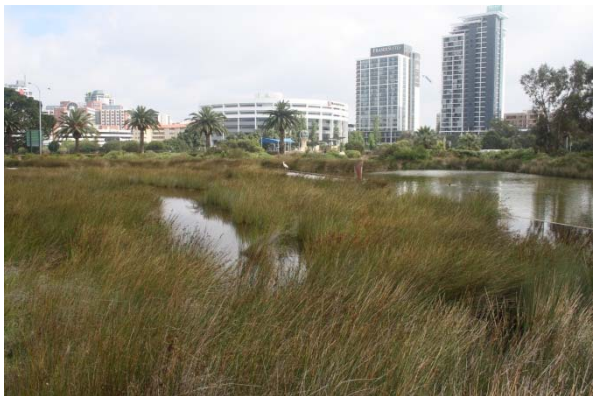
- 1) *Baumea articulata* – the original single patch of *Baumea articulata* sedgeland which expanded (to triple its size) from 2010 to 2011, and contracted in 2012, now covers <1 m² (Table 7, Figure 27). This remaining small patch now contains stressed plants and plants in poor health, suggesting this species and community type will soon disappear from the wetlands. The contraction of *B. articulata* in the wetland appears to have started during spring 2011 (see 2011 monitoring report) and has progressed since. Most deaths appear to be over summer periods suggesting the decline may be caused by drought and/or increased water salinity at this time of the year.

Figure 27. Photograph taken at photopoint WV4 looking north towards city. NB: Direction and elevation of photograph has varied slightly each year, but generally show increase in open water.

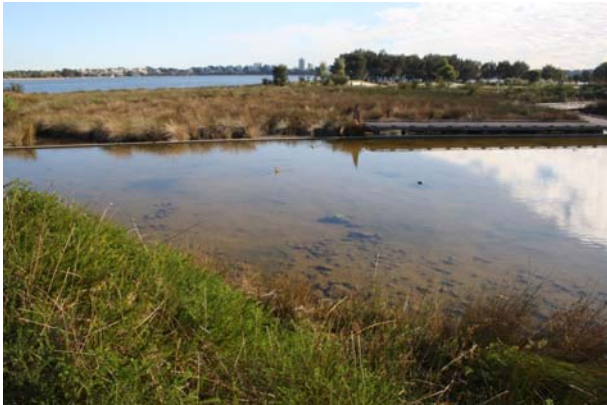
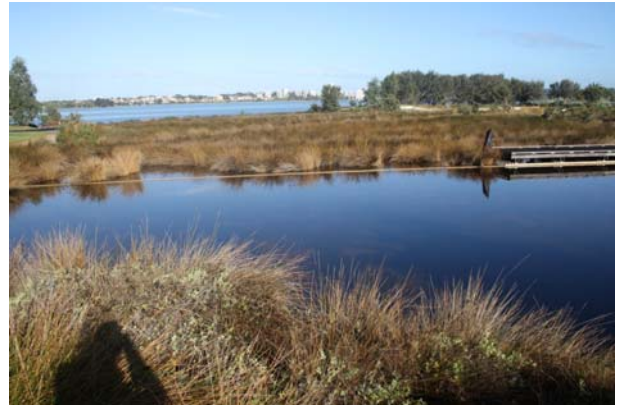
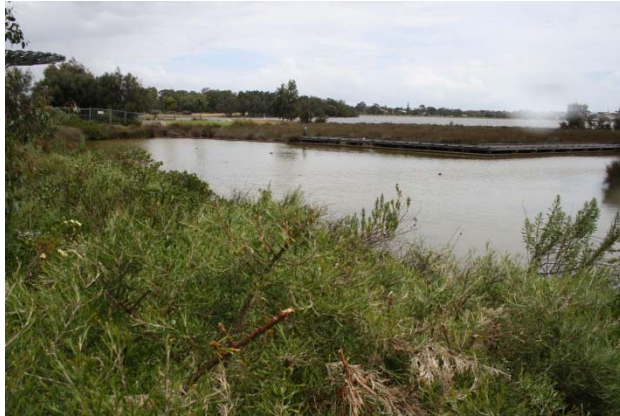
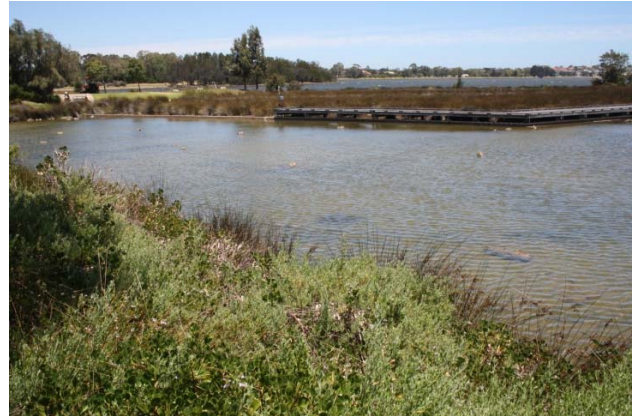
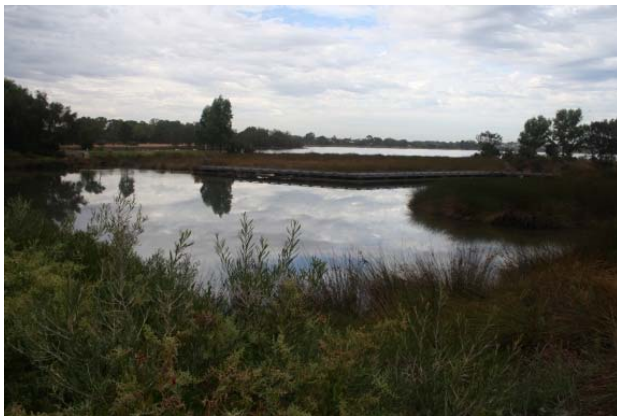
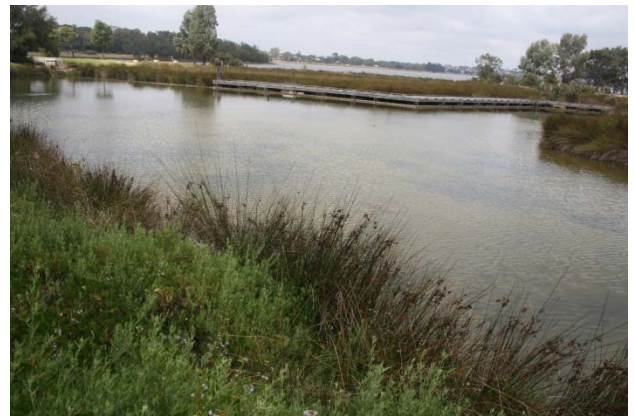
Figure 28. Photographs taken at photopoint WV5 looking south-west

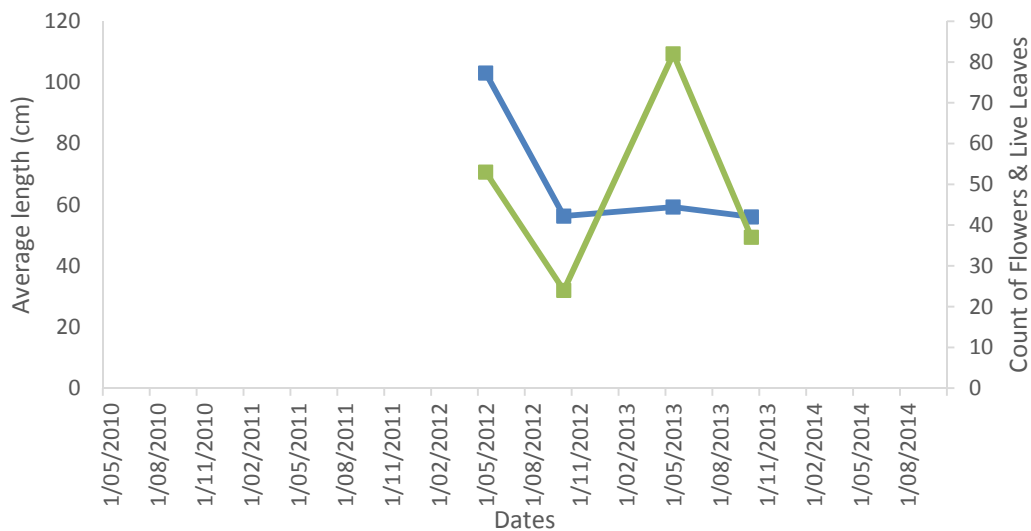
Comparison of the number of live leaves, their average length and the number of leaves with flowers shows that between 2010 and 2014, all species have seen a general decline in average leaf length, with only *J. kraussii* returning to 2010 levels in 2014. The main decline in W3 in average leaf length occurred in October 2011, with a subsequent decline in May 2013 for *J. kraussii* (Figure 30). The number of live leaves generally declined for all species in 2011 and 2013, staging a brief recovery in 2012 before recovering in 2014. Flowers have generally declined for all species, although less so for *J. kraussii*. These results show the impact of increasing salinity within the wetland system. As salinity levels have now been controlled and are decreasing there is some recovery in plant biomass, although reproductive capacity has yet to return to 2010 levels.

Figure 30. Average live leaf length and total counts of leaves with flowers and live leaves from three quadrats from the three ponds W2 – large dash, W3 – solid, and W4– small dash at Point Fraser between 2010 and 2014 for a) *Baumea articulata*, b) *Eleocharis acuta*, c) *Juncus kraussii* and d) *Typha domingensis*.

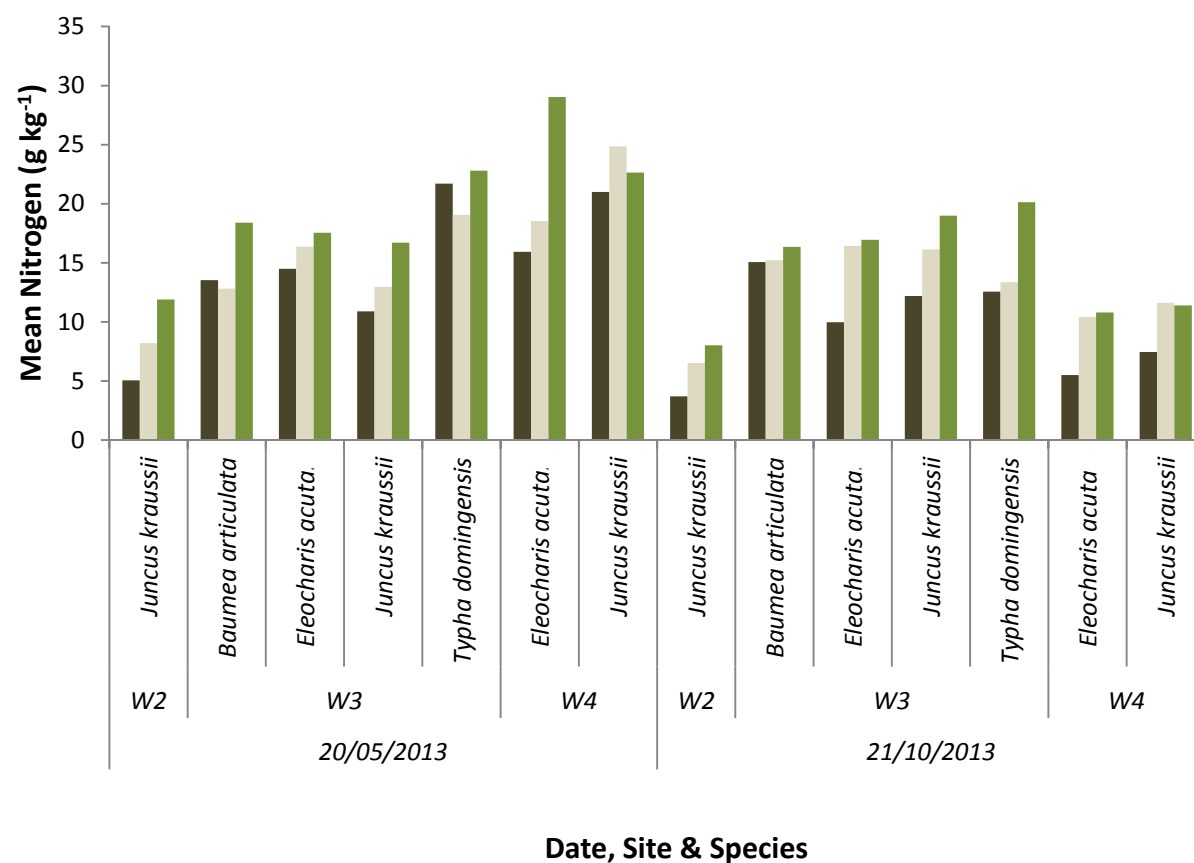
Figure 33. Mean quantities of nitrogen stored per kg of dry weight of live, dead and below ground parts of sampled species, over the seasons and between sites for a) 2014 to e) 2010.

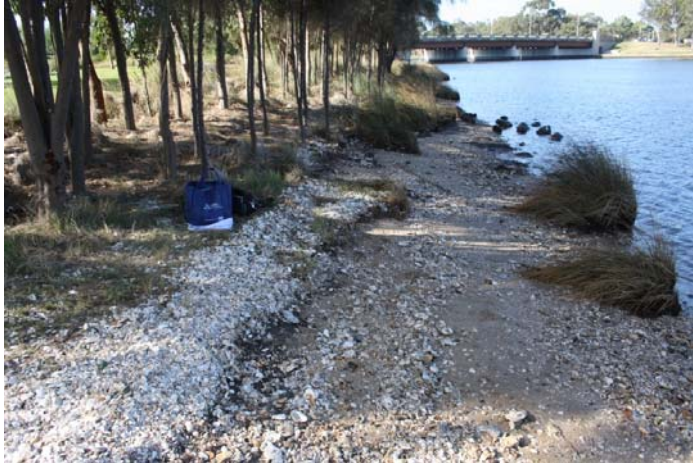
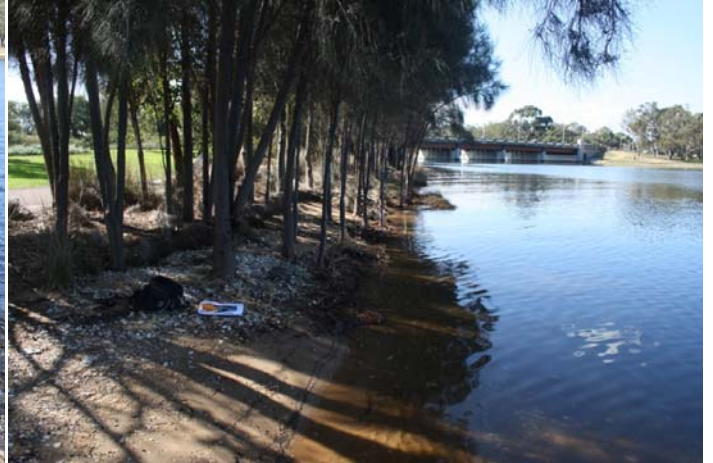
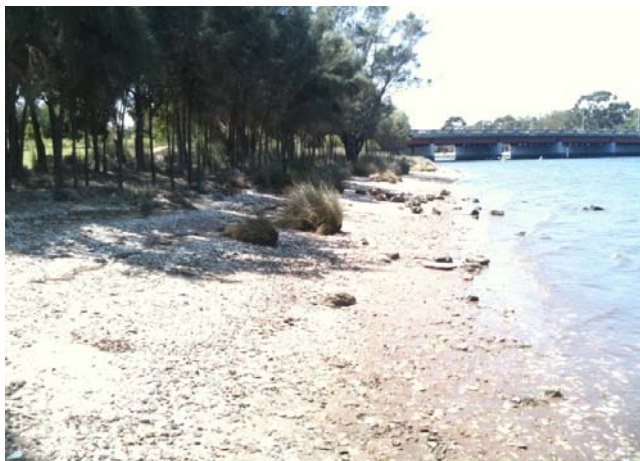
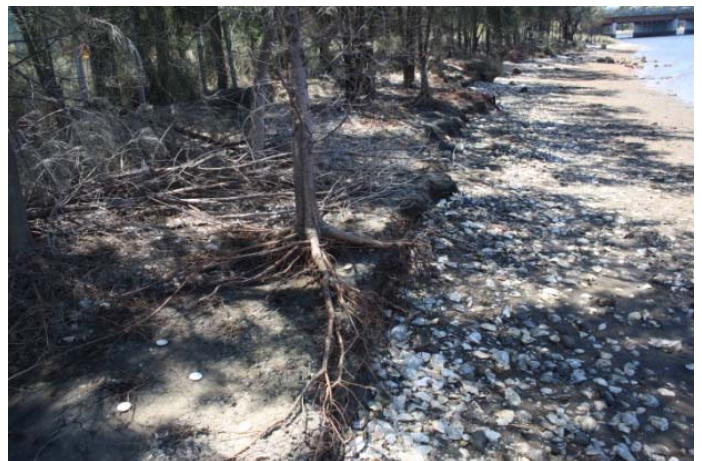
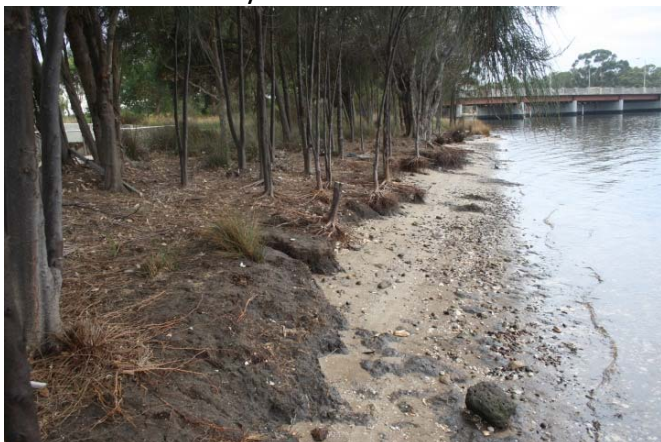
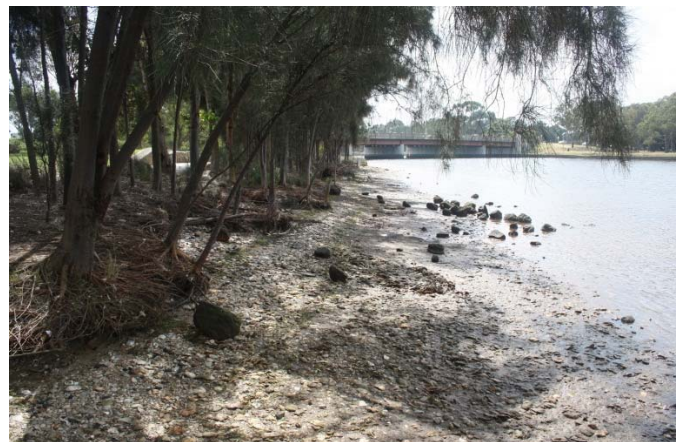
The deterioration in foreshore condition at Monitoring Area 1 measured during previous year has continued in 2013, albeit at a generally slower rate than previous years of monitoring. Further erosion of the river bed has occurred and root systems of recently planted and older *Casuarina* trees on river banks are increasingly being exposed, jeopardising the health of these trees. There are now several dead *Casuarina* trees at the margin (see photographs below), with a few more tree dying at edge during 2013-2014. A slightly greater proportion of foreshore in Monitoring Area 1 is classified as having significant to severe erosion now mostly around 90%, up from average of 80% in 2013, and 20% in 2010; Table 12). Planted and naturally colonised areas of *Juncus* and other fringing wetland plants have all but disappeared along this section of foreshore and this appears to have made the sediment in this area more prone to erosion by waves, which are likely to be mainly driven by wind and the wake of large boats. PVC pipes, presumably buried in the sediment as part of an irrigation system to facilitate revegetation of foreshore, has now been exposed due to erosion, which demonstrates that a strip of sediment several metres wide and up to 30 cm deep has been lost to erosion in Monitoring Area 1. Further exposure of roots is likely which will result in more tree death.

Photographs taken at Foreshore Monitoring Site 1A in an easterly direction. Note: loss of sedge/rush vegetation and increased erosion at the river edge with impacts on trees appearing in 2012-13.

It is recommended that Area 1 (including the headland between Areas 1 & 2) receive immediate remedial treatment in the form of sandbagging, further rock armoury or other re-enforcement, and then infill planting of fringing sedges/rushes to reduce erosion and help prevent further loss of trees. It is noted that some of this work has commenced in 2014.

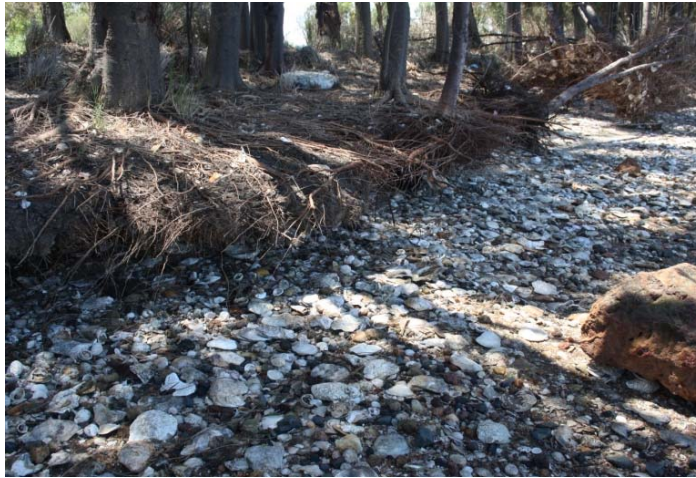
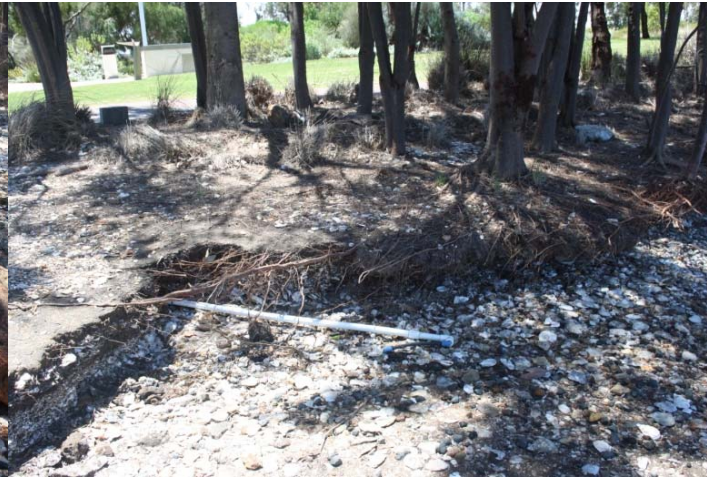
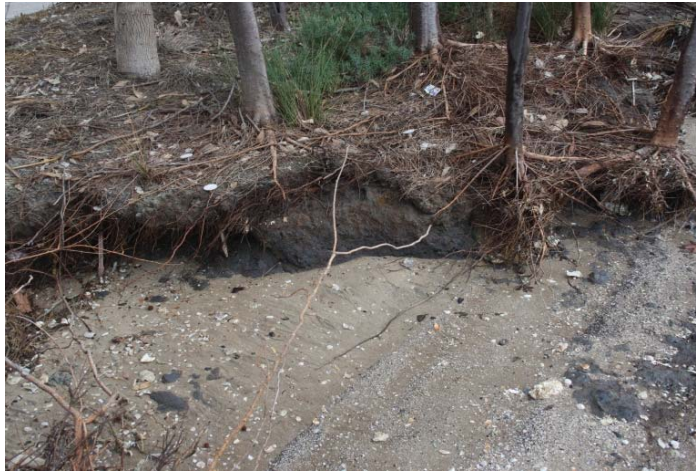
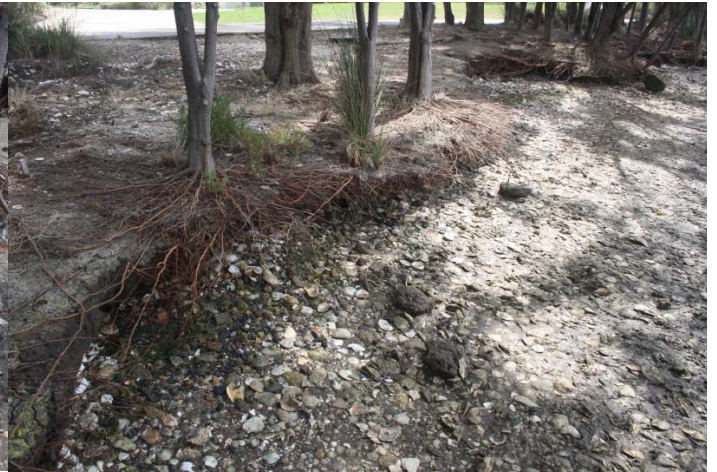
The headland area between Monitoring Areas 1 & 2 has been particularly affected by increased erosion. Since 2010, root systems of several large (and presumably old) *Casuarina* trees had been exposed through erosion of sediment despite various attempts to protect this stand of trees by rock re-enforcement and shells/pebbles. During 2011-12 one very large tree died and fell into the river. The health of several of the other trees (as evident from crown condition) appear to in decline with increasing amounts of erosion and root exposure during 2012-13, with some of these trees dying at the river edge in 2013-14.

Photographs taken at Foreshore Monitoring Site 1A showing severe erosion
