Point Fraser Monitoring and Evaluation Program

2014 Report and 5 Year Report

Prepared for,
City of Perth

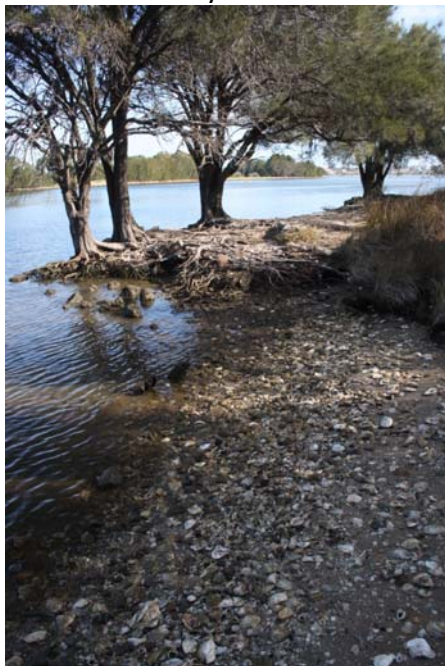
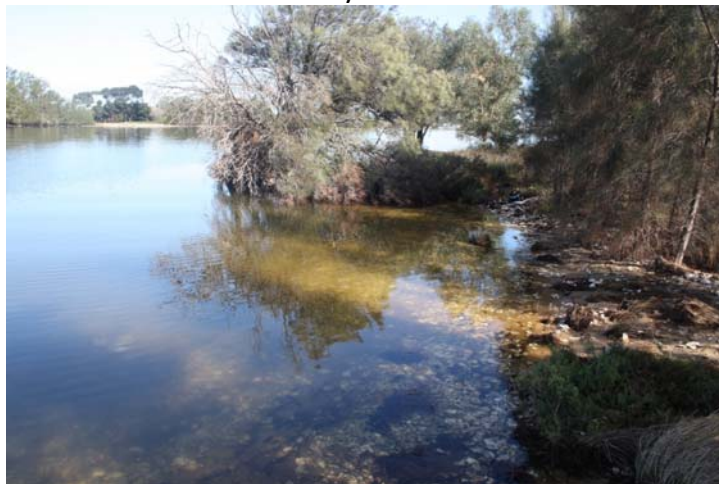
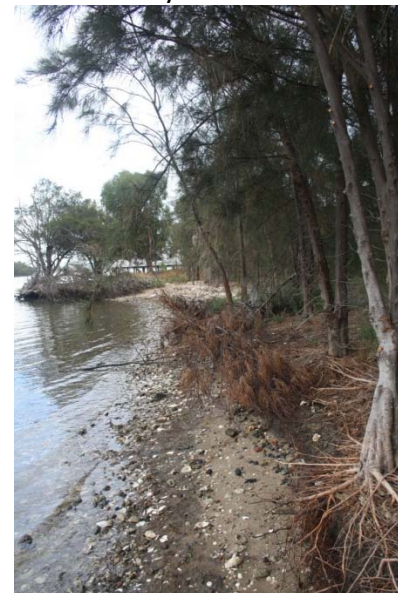
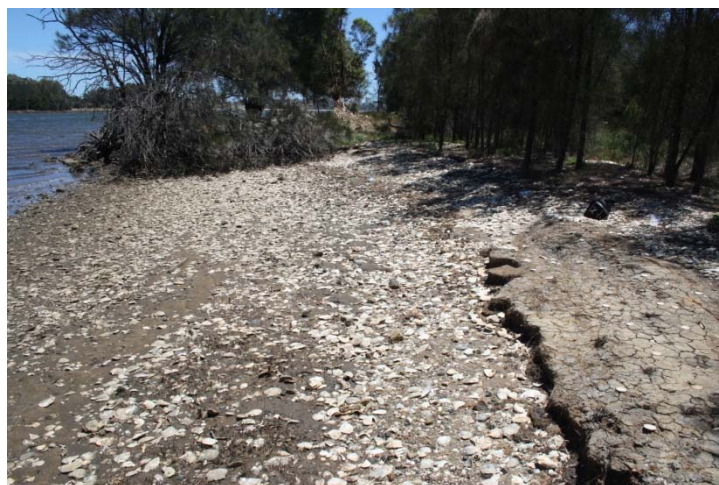
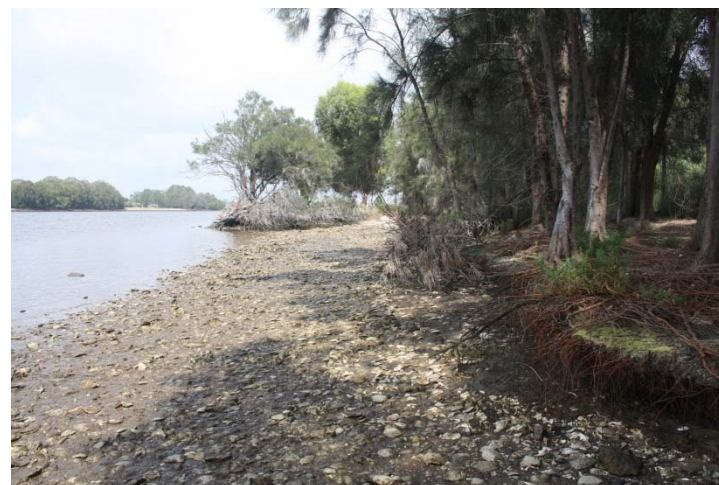
Photographs taken at Foreshore Monitoring Site 1B in westerly direction. Note: *Casuarina* tree on headland has fallen into the river.

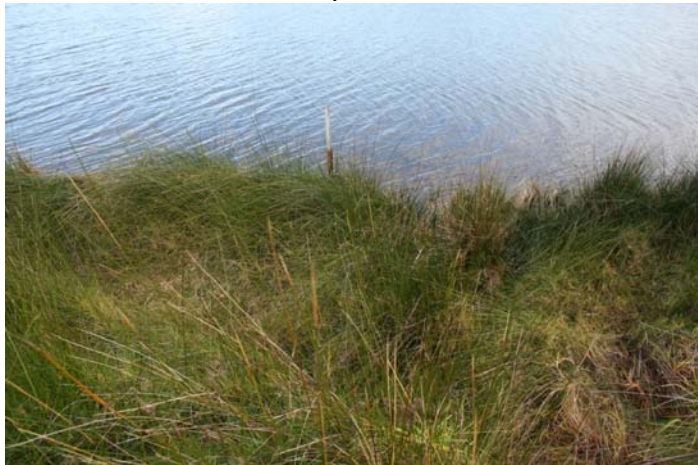
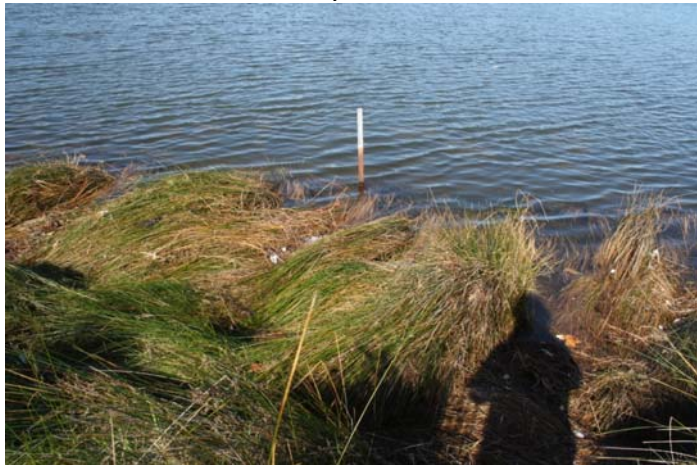
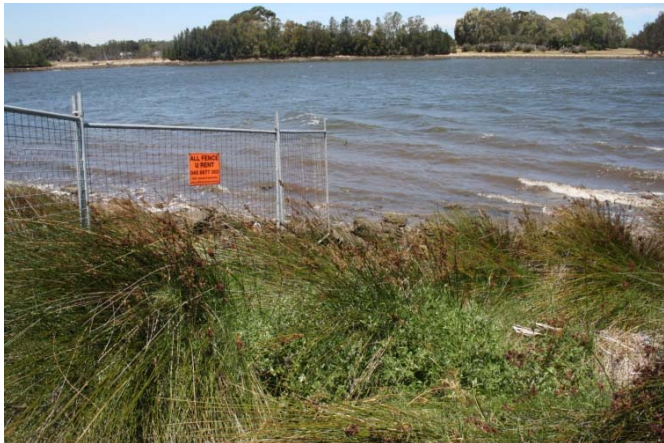
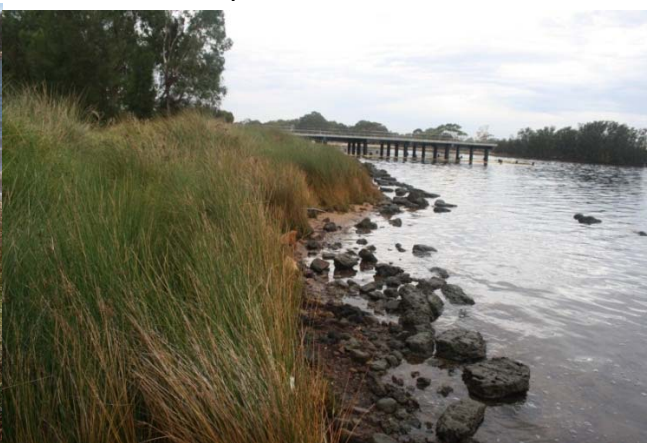
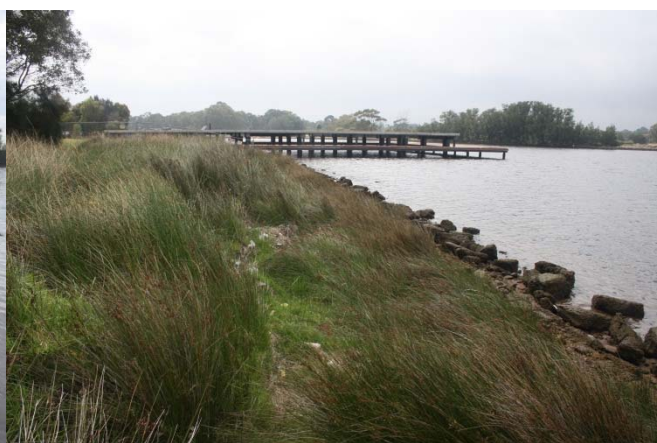
Photographs taken at Foreshore Monitoring Site 2A in a Southerly direction. Note access to this site was restricted in 2012-14 due to redevelopment program

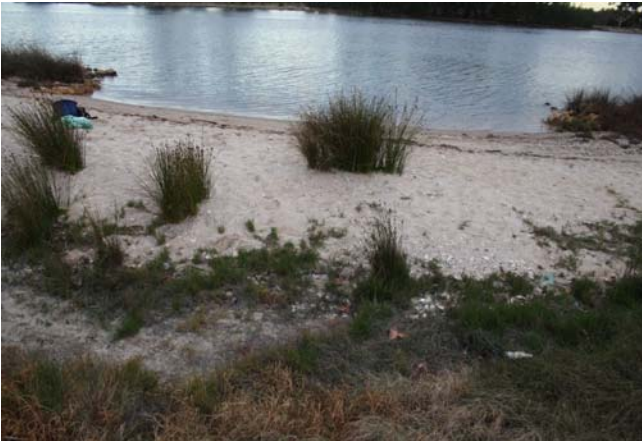
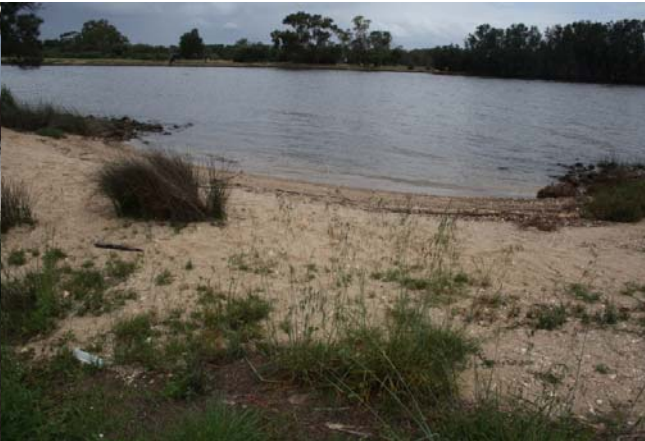
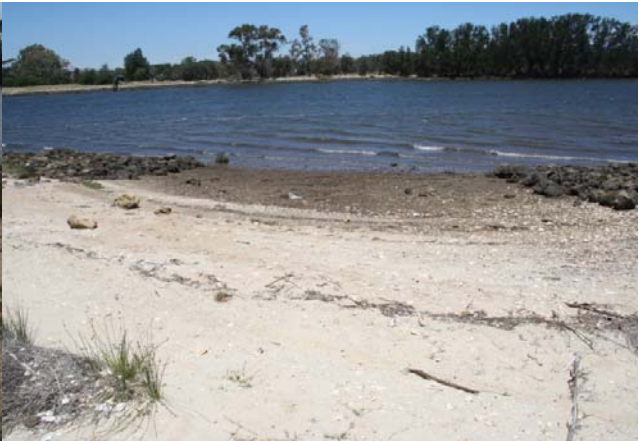
Photographs taken at Foreshore Monitoring Site 2C in Southerly direction

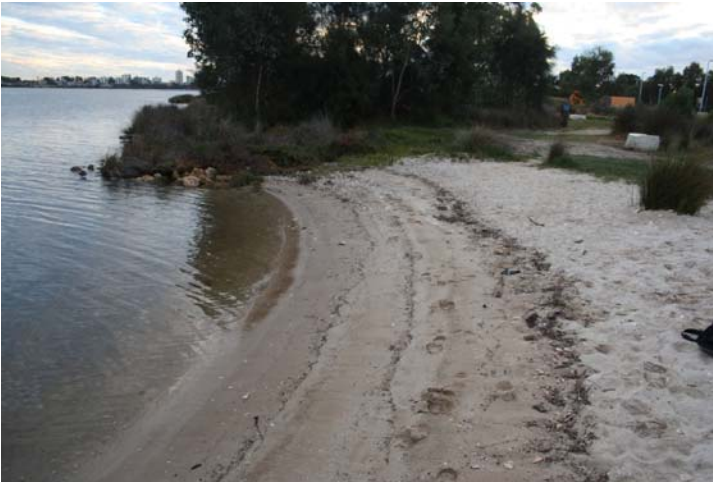
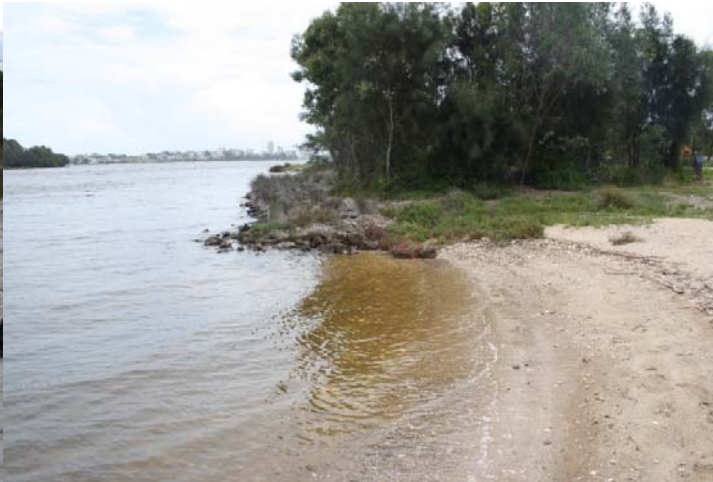
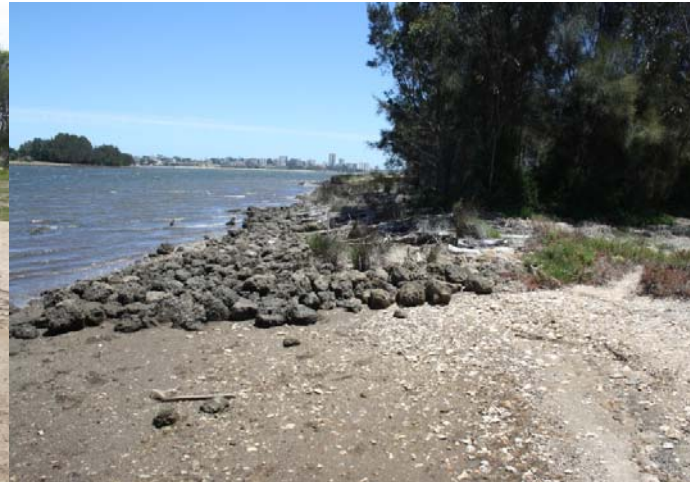
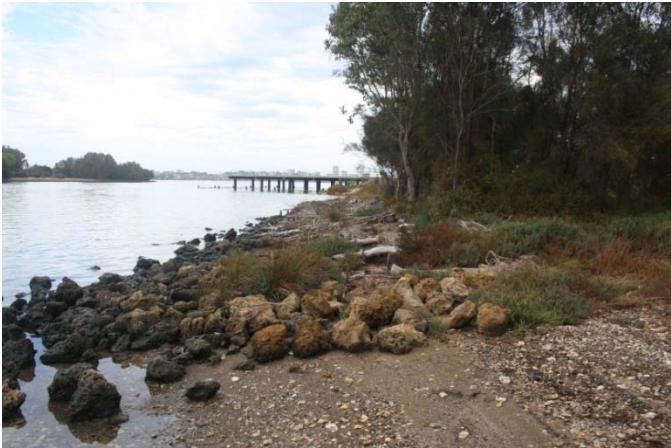
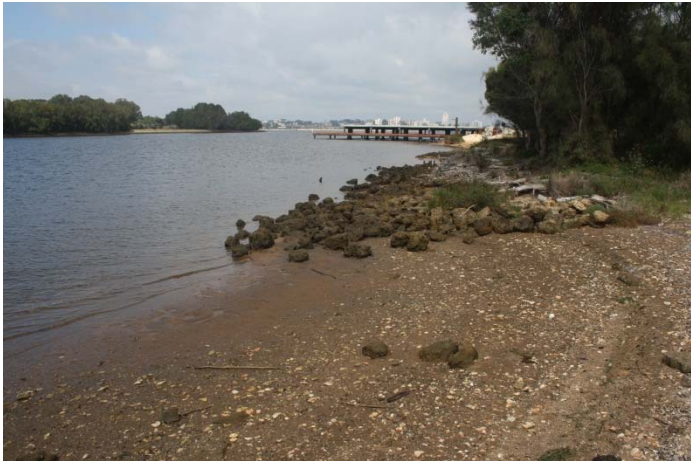
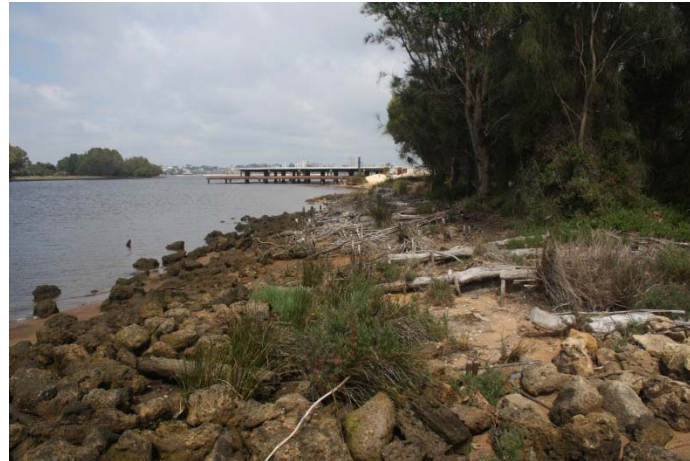
Photographs taken at Foreshore Monitoring Site 2C in a Westerly direction

Sites have been established and monitored for the five years of the project. Significant erosion due to winter storms has caused considerable erosion and loss of vegetation over most of the foreshore.

10. Ongoing vegetation monitoring for nutrients and biomass is not considered necessary. It is recommended that annual assessments of the plant coverage are continued so that changes in coverage and possible die-back are detected allowing appropriate actions to be taken.
11. It is recommended that remediation activities be undertaken as soon as possible to protect the foreshore and existing vegetation along Area 1.
12. It is recommended that ongoing monitoring of the foreshore continue as detailed in the PFMEP. However, it is essential that action is taken by the City as soon as issues are reported to protect the foreshore.

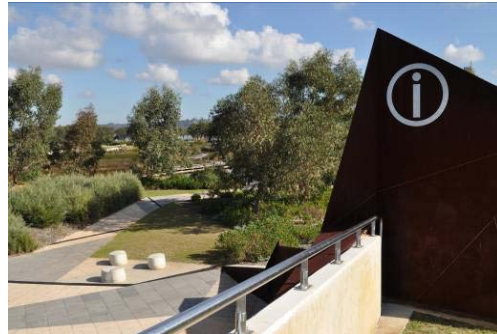
Lookout

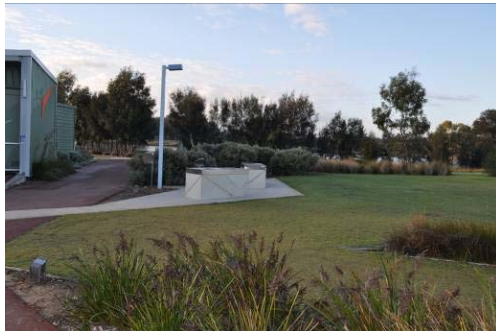
BBQ – note lack of table, seating or shade

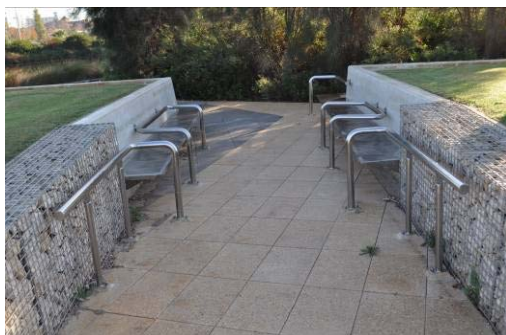
Example of seating – not amenable for a family picnic or barbeque

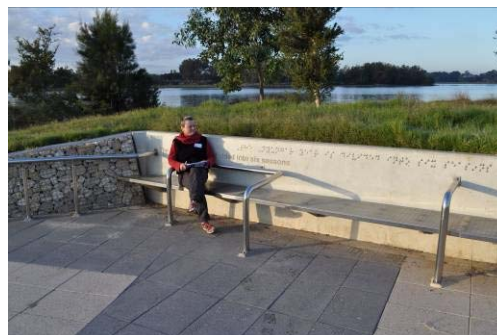
Example of seating – artistic but impractical and uncomfortable

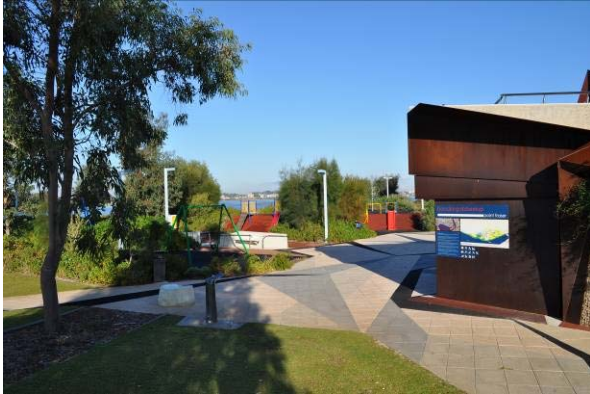
View towards playground and Kiosk (not operational)

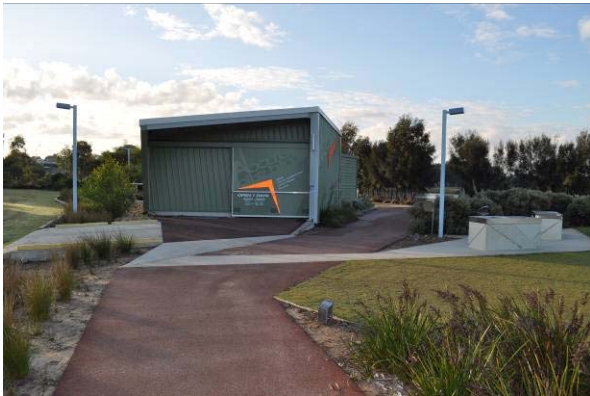
Hire store - closed

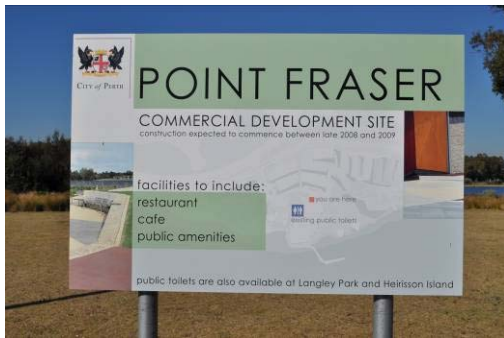
Out of date sign highlighting the development of a café / restaurant commencing in 2008 or 2009

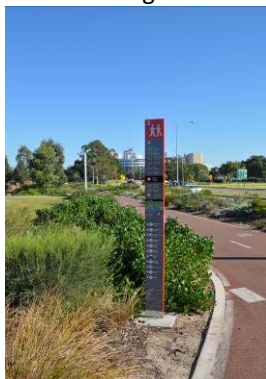
Directional sign along outside bike path – very small print and lots of writing

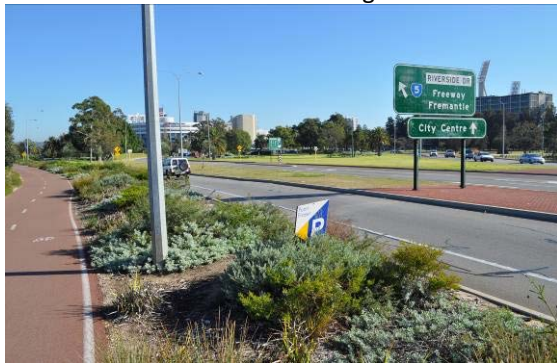
Car park entrance sign along road – obstructed by shrubs

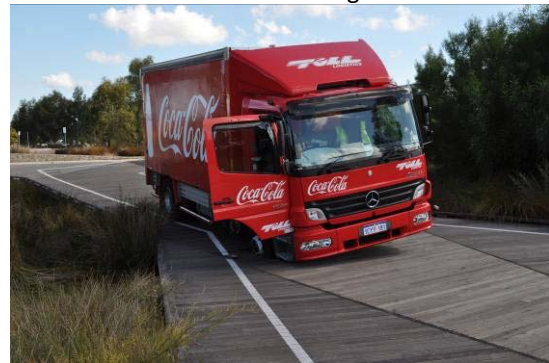
Lack of signage? – Driver got confused in the car park area how to get to About Bike Hire and attempted access via the boardwalk from the car park

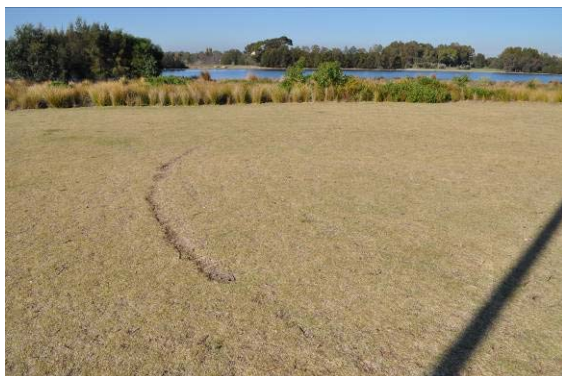
Damaged lawn from vandals conducting donuts with cars

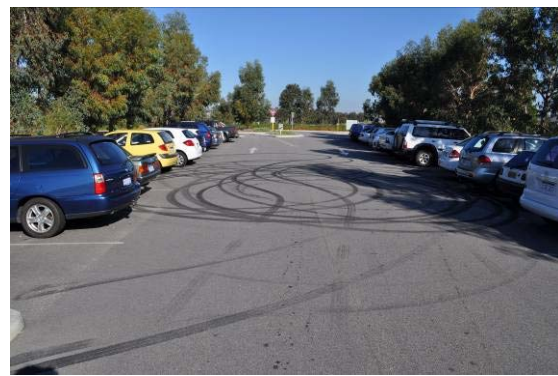
Tire marks in car park from vandals conducting donuts and burnouts with cars
