# **Breach and decant of an acid mine lake by a eutrophic river: River water quality and limitations of use**

**Clint D. McCullough**, Golder Associates & Mine Water and Environment Research Centre (MiWER),  
Edith Cowan University, Australia  
**Elmien Ballot**, Premier Coal, Australia  
**Digby Short**, Premier Coal, Australia

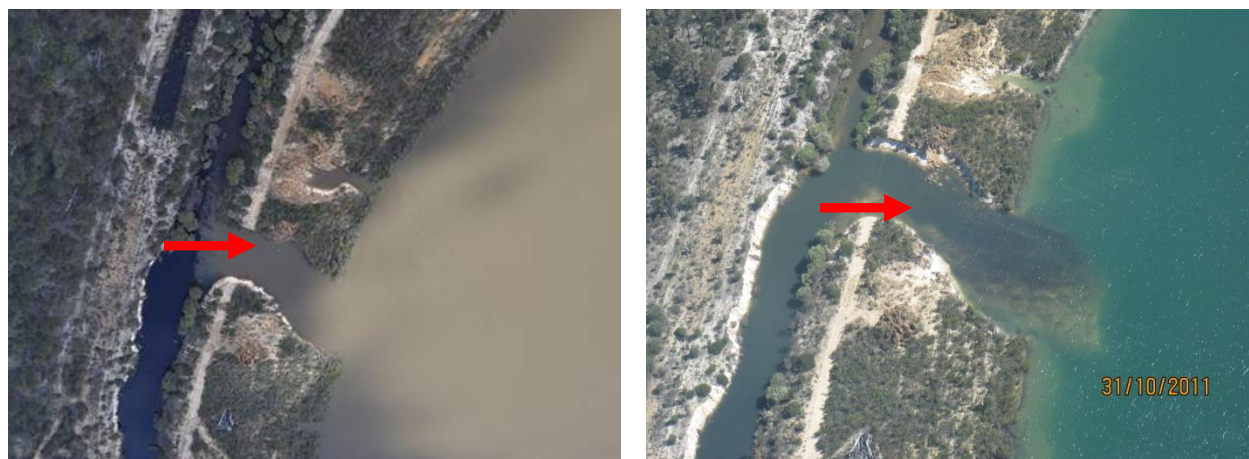
**Figure 2: Aerial view of Lake breach point in September 2011 (left) and October 2011 (right). Top of left photo points south, right photo points north (Digby Red arrows indicate the River breach point)**

During the third week of August 2011, a rainfall of 85.6 mm (BOM 25/03/2012) in Collie over 48 h led to high flows in the CRSB. The water level in the CRSB rose, overtopping and then eroding the engineered northern dyke wall that separated it from the lake. As a result, water levels in Lake Kepwari rose 1.7 m over the Lake's new surface area of 106 ha representing around 6% of the lake volume. Lake water then decanted through a previously designed outlet before overtopping this and then decanting back through the breach as River levels dropped. There is now a permanent connection to the river and lake at the breach point and through the previously designed lake overflow.

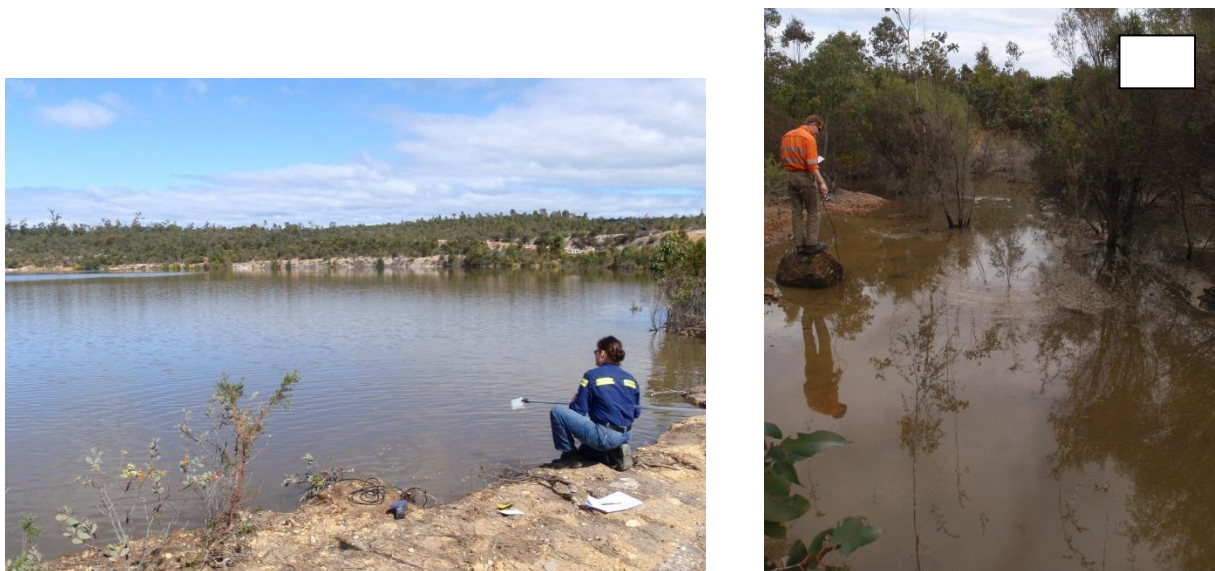
**Figure 3: Sampling (left) immediately above in Lake Kepwari and (right) immediately below Lake decant in the CRSB on August 2011**

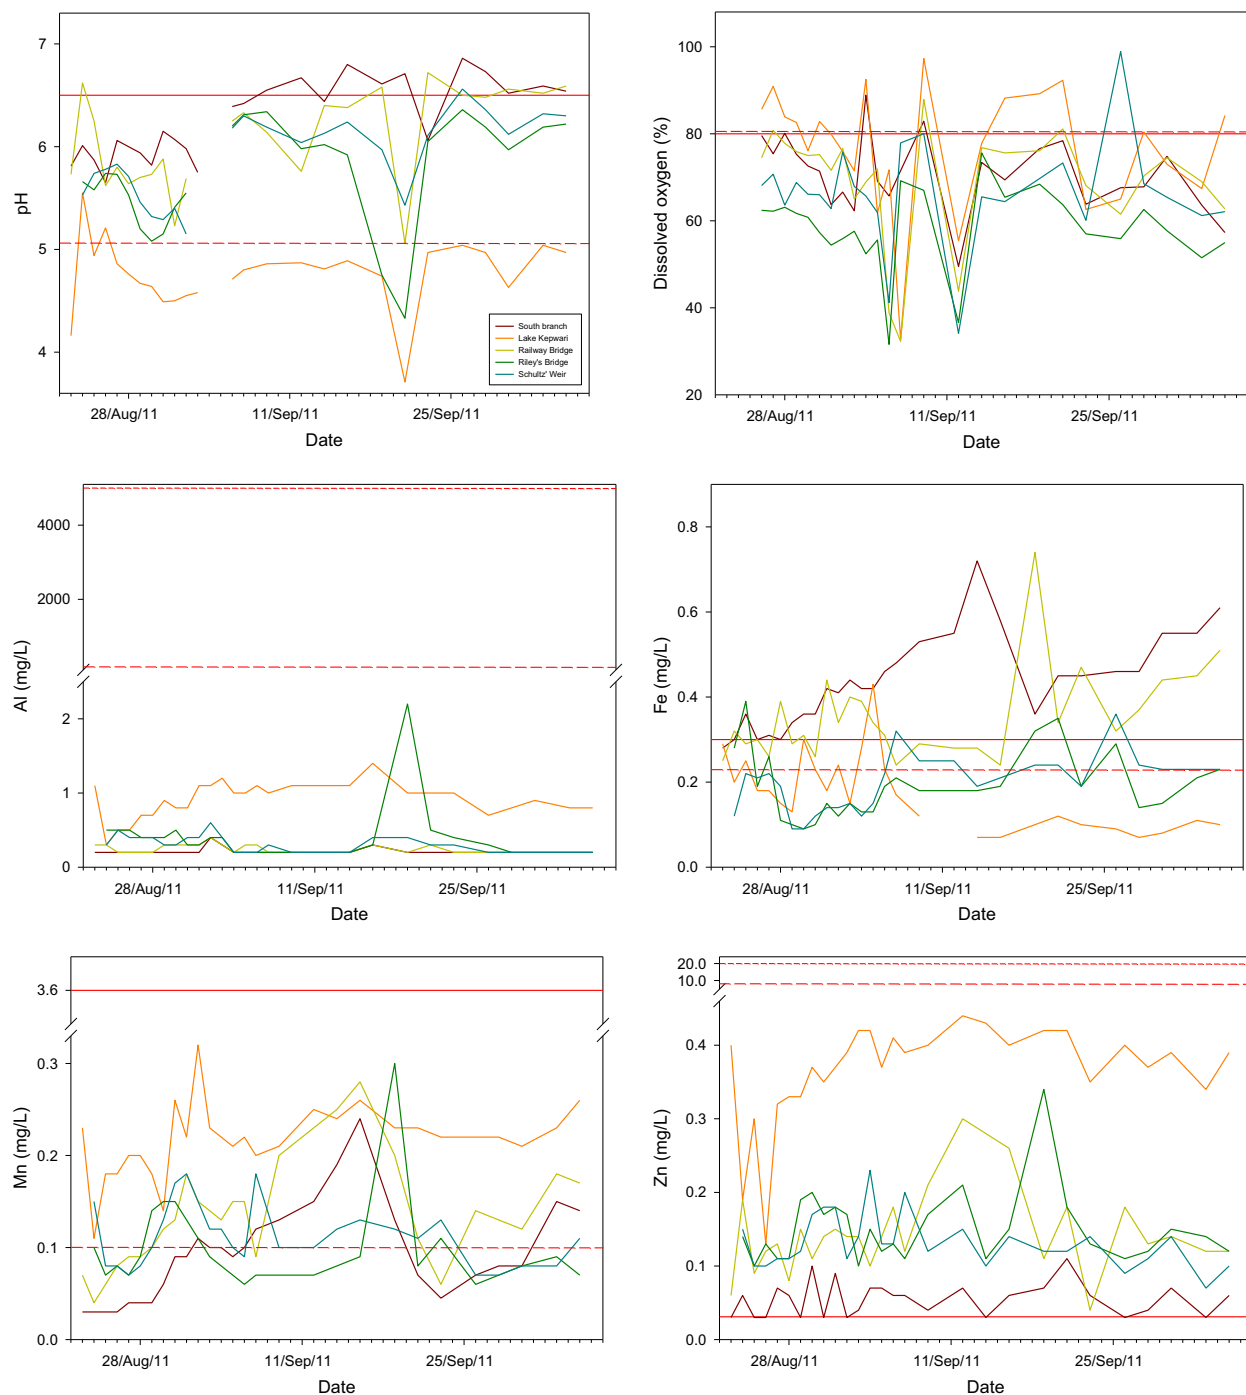
Water quality values recorded in the Collie River and Lake Kepwari during the six week monitoring period following the breach are shown in Figure 4. The legend lists sampling locations in succession, beginning at the most upstream reference site (South Branch), through to Lake Kepwari itself and ending at the most downstream reference site below Lake Kepwari (Schultzes Weir).

**Figure 4: Water quality in Lake Kepwari and the Collie River between 23 August and 24 October 2011 for selected parameters (ANZECC/ARMCANZ 2000)**

**Note:** Line gaps show missing data and red lines indicate guideline levels: solid lines Ecosystem Protection, dashed lines Primary Recreation and dotted line Stock Drinking Guidelines

Lake Kepwari exceeded guideline levels for Primary Contact Recreation at all times except for two sampling events shortly after breach. pH values at all sites were also below the lower 95% Ecosystem Protection guideline of 6.5 for most of the sampling period apart from CRSB which rose above this guideline around two weeks after breach. A sudden decrease in pH occurred during the period 19 to 21

September in Lake Kepwari and at all downstream sites. It is unclear how this could have occurred unless inflows of River water through the breach point led to a short period of mixing resulting in the lake's hypolimnion water being mobilized into the upper water column. This lower pH water would then have been carried out of Lake Kepwari water and down through the Collie River. An alternative or complimentary explanation is that Lake water decanted back out through the breach point following River flow decline and resulting height decrease leading to a hydraulic gradient back to the main River stem. This lower pH water would then have been carried out of Lake Kepwari water and down through the Collie River. A rainfall event of 28 mm was recorded at nearby Muja Power Station #9738 on 18 September 2011 (BOM 25/03/2012), which supports this latter conclusion.

Dissolved oxygen (DO) was below Recreation and 95% Ecosystem Protection guidelines of 80% in all sites for much of the monitoring period, although DO was generally high in Lake Kepwari. DO decreased lower in the CRSB likely due to biochemical oxygen demand by decaying organic matter from allochthonous vegetation (Wetland Research & Management 2009).

Aluminum concentrations were well below Recreation and Stock Drinking Water guidelines at all sites and times. Although there are no 80% Ecosystem Protection guidelines for pH <6.5, Al concentrations at the majority of sites were also likely to contribute toxicity through increased monovalent Al ion concentration at these lower pH values (Neil et al. 2009). An unusually high Al concentration at Rileys Bridge on 19 September of 2.2 mg/l indicated a further source of Al input to the River above this point, most likely from another mine water discharge. Water quality results suggest that, although Al concentrations were slightly elevated in background conditions of the Collie River, in and downstream of Lake Kepwari had elevated Al concentrations.

Fe concentrations exceeded the Australasian Recreational and Aesthetic water quality and interim working Ecosystem Protection guidelines of 0.2 and 0.3 mg/l respectively at most sites during the sampling period. A noticeable spike in Fe concentration occurred at the South Branch on 14 September with a likely resulting subsequent spike at Railway Bridge downstream on the 19 September. Indeed, highest concentrations were from uppermost sites; including background concentration from the South Branch. These results indicated that reference concentrations are typically elevated in the Collie River and Lake Kepwari is likely not significantly influencing Fe concentrations downstream.

All sites exceeded Recreational and Aesthetic guidelines for Mn, with highest concentrations in Lake Kepwari. However, as with Al, an unusually high Mn concentration at Rileys Bridge on 19 September of 0.3 mg/l indicated a further source of Mn to the River; again, most likely from another, undetermined, mine water discharge to the river. South Branch reference site concentrations above the guideline indicate that Mn concentrations are already elevated in the CRSB. Nonetheless, Mn concentrations did not exceed 80% Ecosystem Protection guideline of 3.6 mg/l.

Zinc concentrations exceeded 80% Ecosystem Protection guidelines of 0.031 mg/l at all sites during the six week sampling period. Zn concentrations were highest in Lake Kepwari at around 0.4 mg/l and then doubled from background South Branch concentrations of around 0.08 mg/l to around 0.15 mg/l downstream after mixing with Lake decant water. Another spike in elevation at Rileys Bridge again indicated another mine water source of Zn above this site. Zinc concentrations did not come close to exceeding the Recreational and Aesthetic guideline of 8 mg/l or Livestock Drinking guidelines of 20 mg/l during the monitoring period.
